SAMPLE REPORT

MACHINERY VIBRATION REPORT

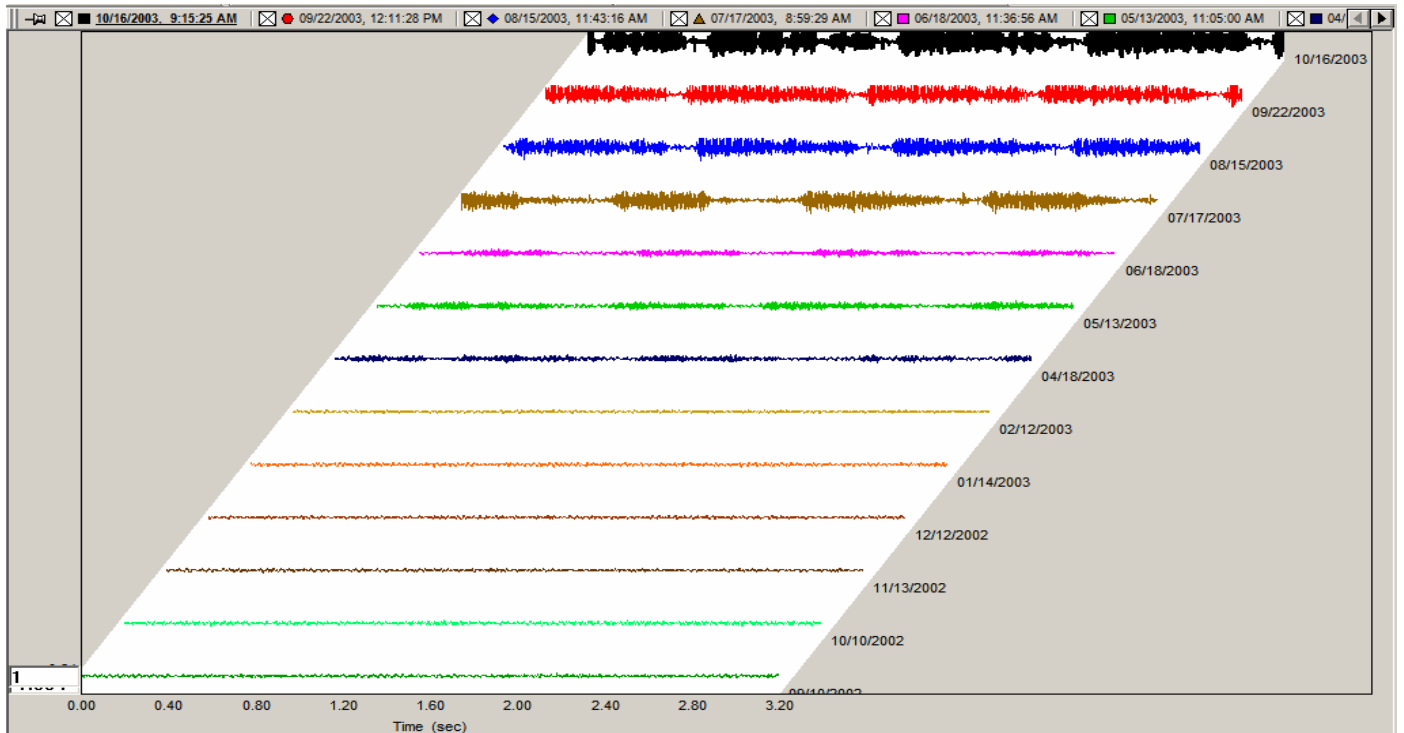
EQUIPMENT NAME	PROBLEM DESCRIPTION	PRIORITY
Primary Conveyor Gravity Takeup, Upper Bend Roll	Continue to note possible wear in spectral data of non-drive end upper bend bearing / roll. Impacting remains in time waveform data at shaft speed. See attachment for waterfall of time waveform.	Med-High

RECOMMENDED ACTION: Check shaft and roll for possible cracks / fatigue, bearing should be checked for excessive clearance / wear.

Problem Found / Action Taken	Bushing broke. Changed bushing.
------------------------------	---------------------------------
