THERMOGRAPHIC REPORT

Company | XYZ

Location Name | Location 8

Equipment | Machine #64

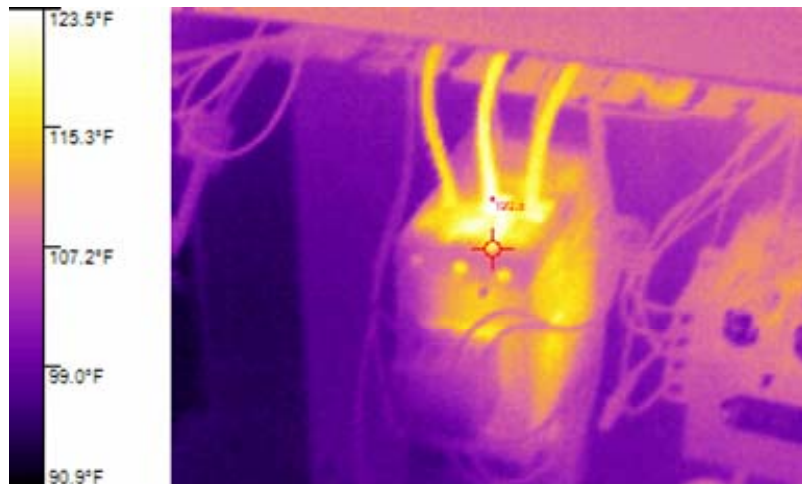
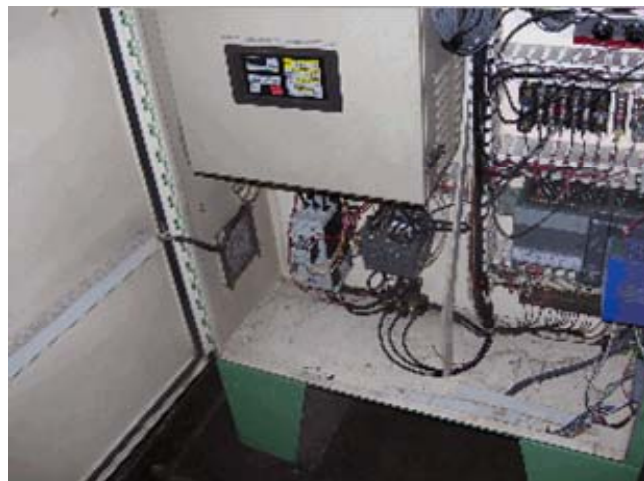
Siemens contact block in bottom left of disconnect panel is hot.

Image Date	8/28/2007 11:22:28 PM
Target Temperature	116.5 °F
Emissivity	0.99
Reflected Temp	OFF

REPAIR PRIORITY **Med-High**

Description	Repaired by
Possible loose lead. Ensure tight connection.

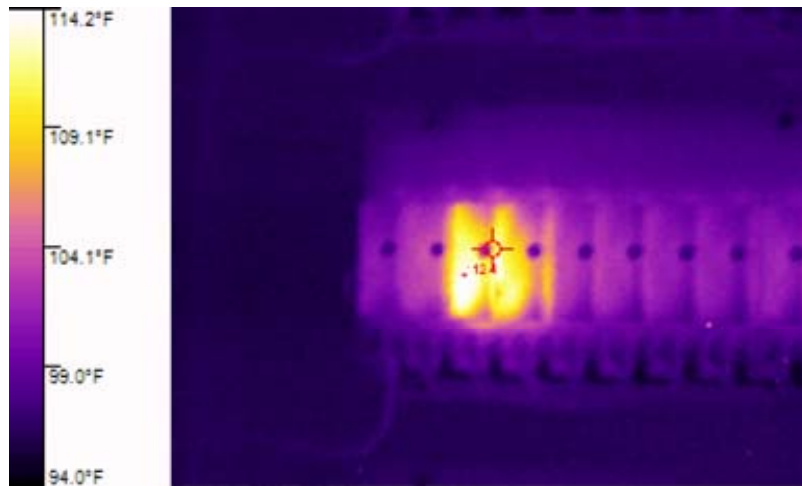
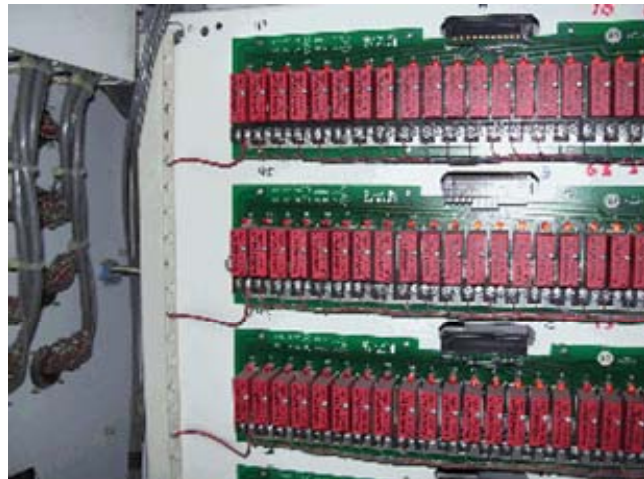
Clutch #91 relay is hot.

Image Date	8/28/2007 4:44:15 AM
Target Temperature	107.1 °F
Emissivity	0.94
Reflected Temp	OFF

REPAIR PRIORITY **Med-High**

Description	Repaired by
Possible defective relay. Replace relay.
