# SAMPLE REPORT

## MACHINERY VIBRATION REPORT

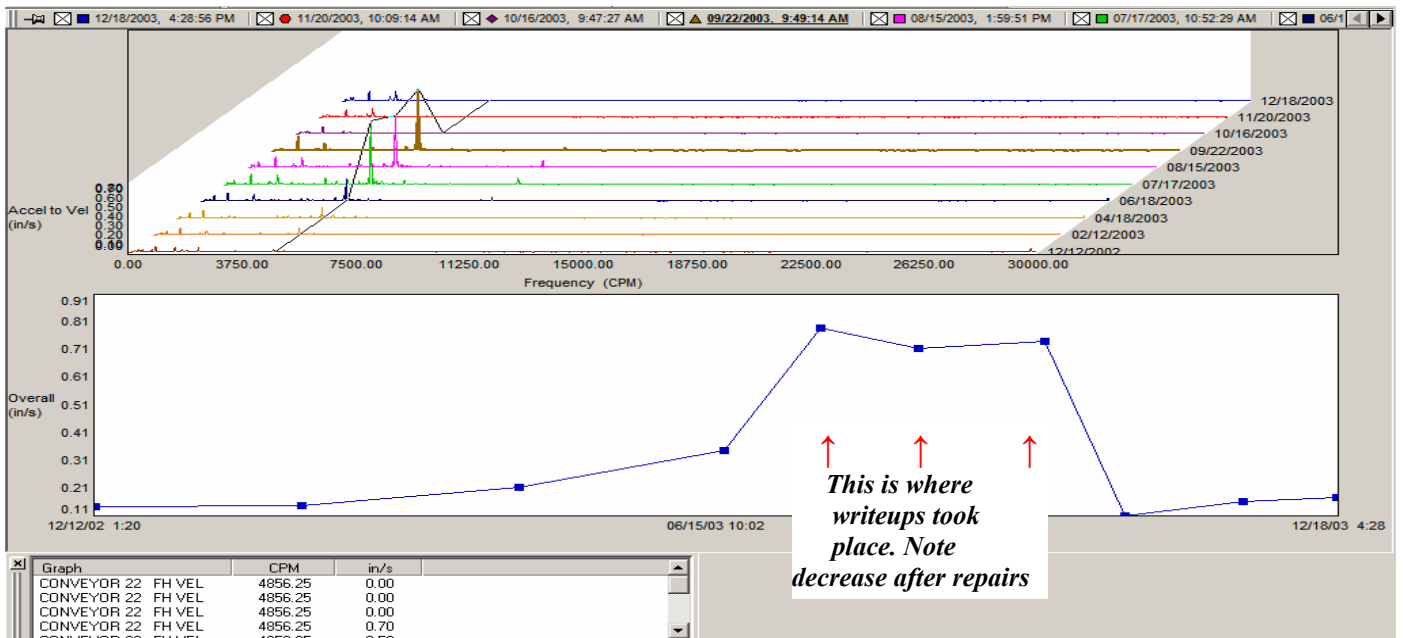
EQUIPMENT NAME	PROBLEM DESCRIPTION	PRIORITY
Conveyor 22 (10000122)	HFD levels continue to trend upward at output of gearbox, vibration at suspected gearmeshing frequency of the output gearset continues to increase. Suspect extensive wear in output gearset. See attachment for waterfall spectral plot. <a href="#">No current oil sample noted online.</a>	High
RECOMMENDED ACTION:	Replace / recondition gearbox promptly.	
<i>Problem Found / Action Taken</i>	Broken tooth / wear on pinion of output gearset.

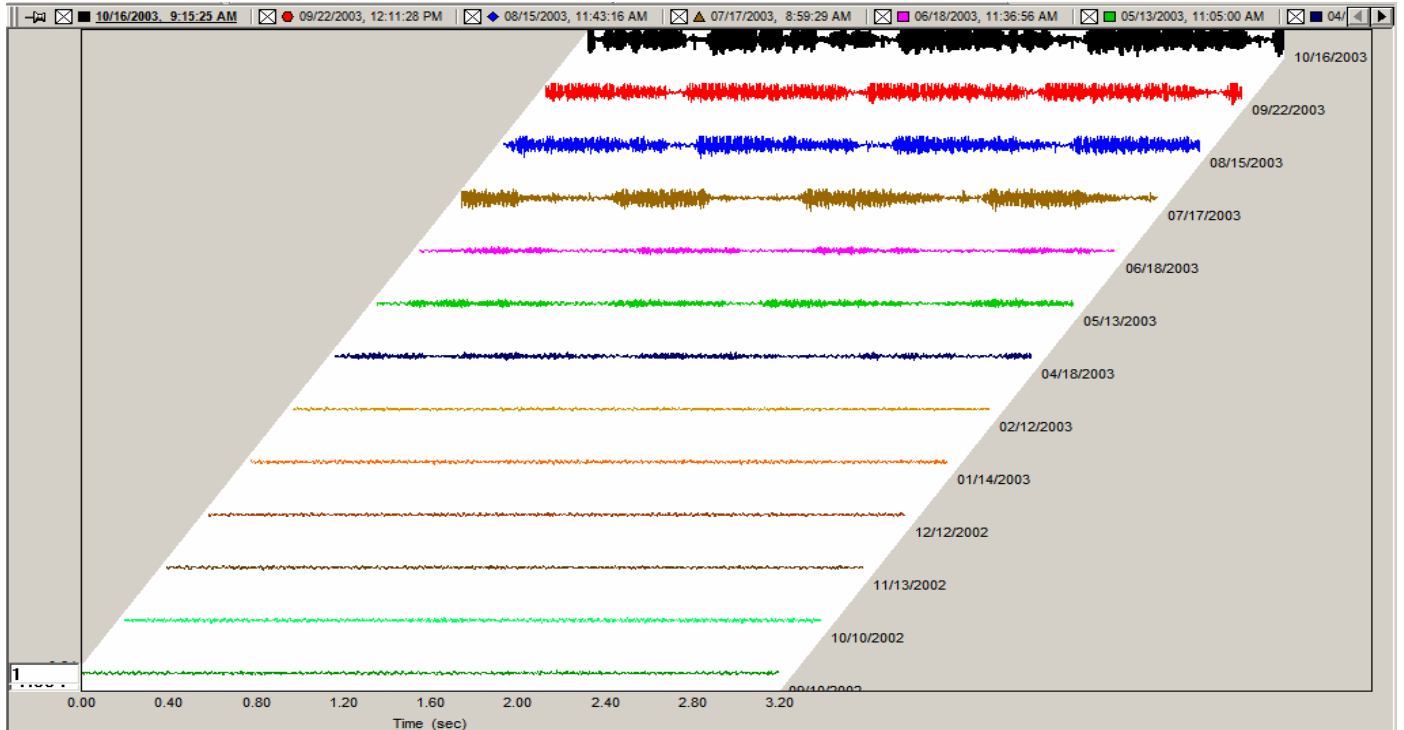
<b>Primary Conveyor Gravity Takeup, Upper Bend Roll</b>	Continue to note possible wear in spectral data of non-drive end upper bend bearing / roll. Impacting remains in time waveform data at shaft speed. See attachment for waterfall of time waveform.	<b>Med-High</b>
---	--	-----------------

RECOMMENDED ACTION: Check shaft and roll for possible cracks / fatigue, bearing should be checked for excessive clearance / wear.

<i>Problem Found / Action Taken</i>	Bushing broke. Changed bushing.
-------------------------------------	---------------------------------

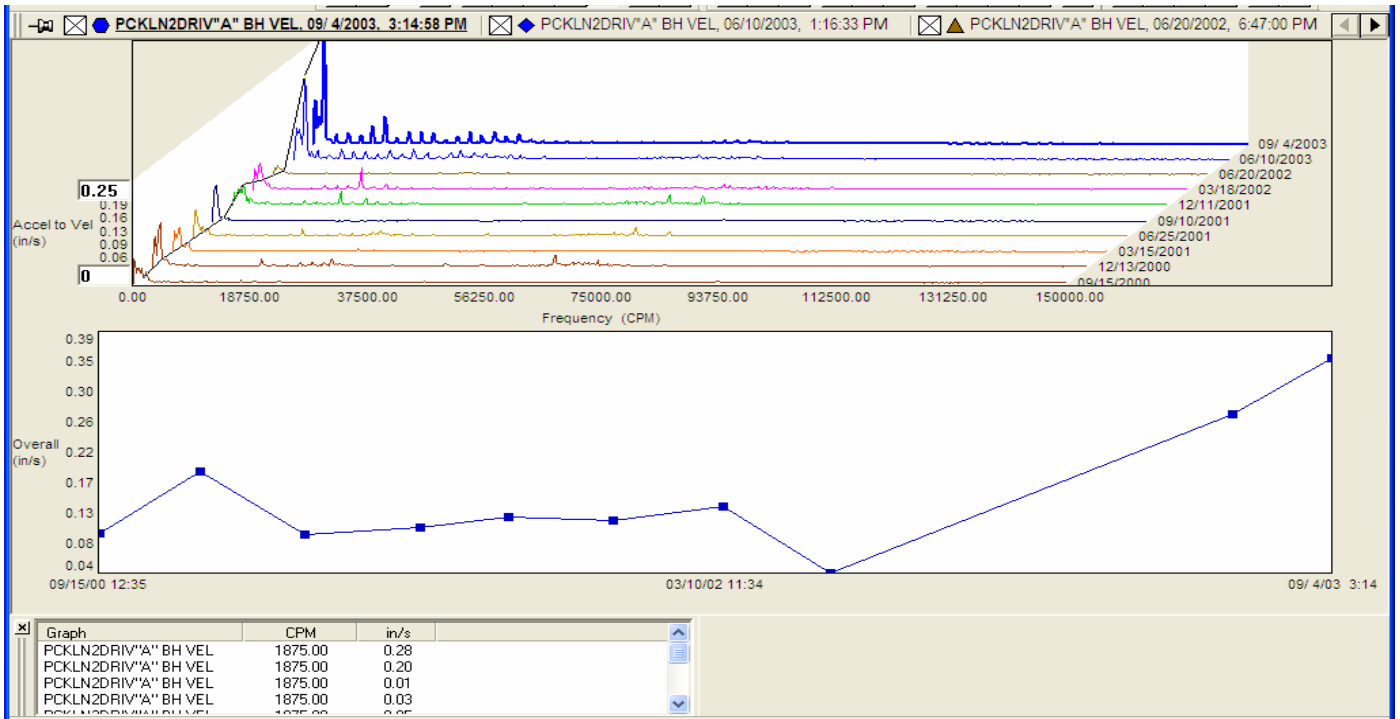
EQUIPMENT NAME	PROBLEM DESCRIPTION	PRIORITY
Pick Line 2 "A" Drive	Continue to note looseness in spectral data. See attachment for waterfall spectral plot.	Medium
RECOMMENDED ACTION:	Inspect coupling for wear or damage. Check for loose play in motor and also at input of gearbox.

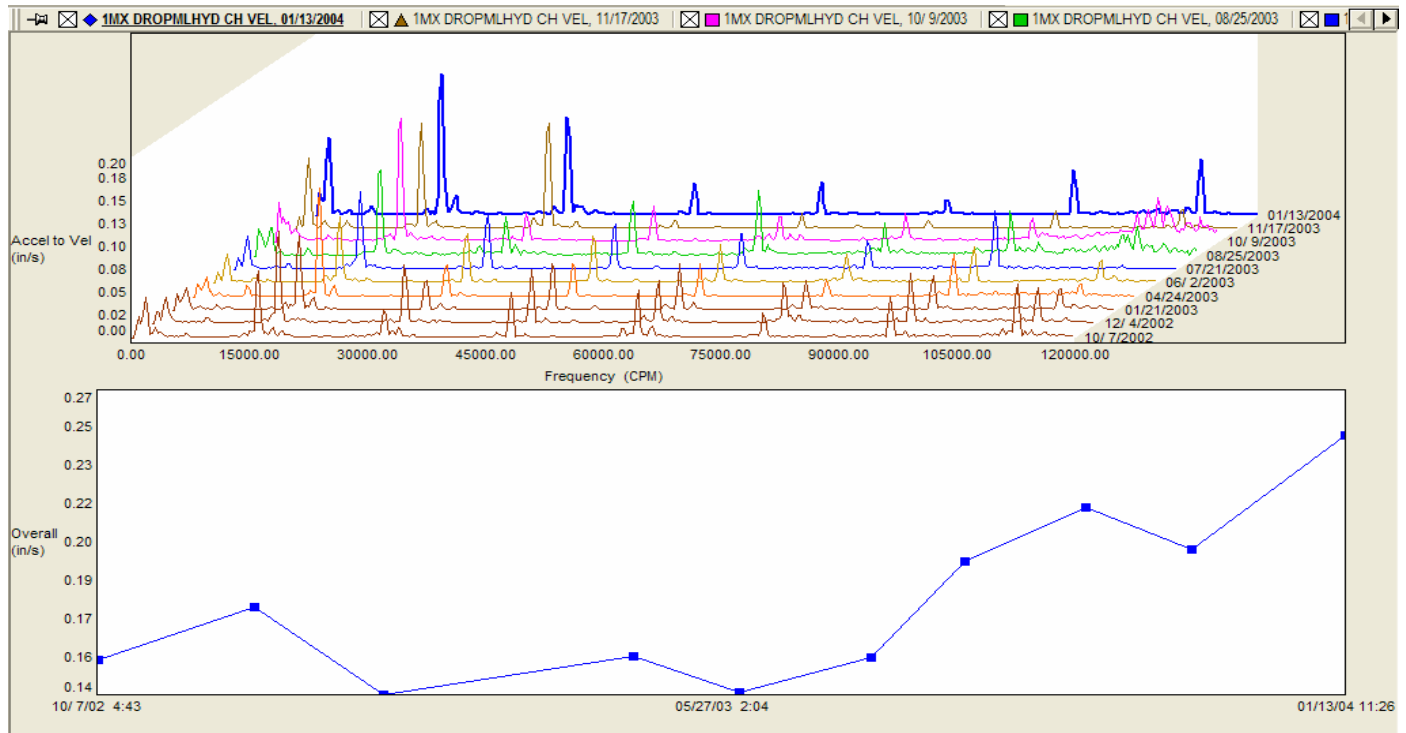
EQUIPMENT NAME	PROBLEM DESCRIPTION	PRIORITY
#1 Mixing Drop Mill Hydraulic Pump	A critical alarm was issued for the velocity on the hydraulic pump. Velocity levels are trending upward on new pump. Waterfall spectral show increased vibration at the pump speed (1800 RPM) and harmonics of the pump gear/piston/vane frequency. This may indicate a restriction in the flow or improper relief. Refer to attachment for pump velocity waterfall plot and trend.	Med-high
RECOMMENDED ACTION:	Check pump for possible obstructed / impeded flow. Check relief valves for proper operation and setting.

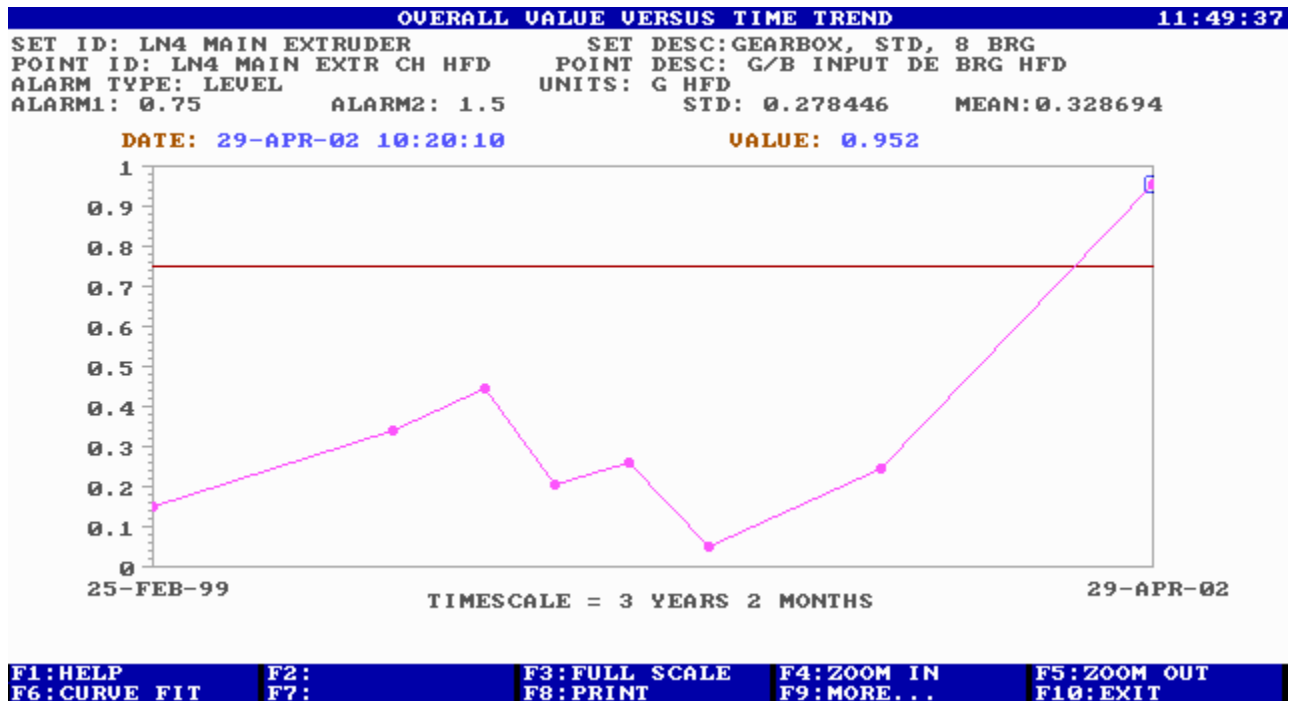
<b>Line 4 Main Extruder</b>	Increased HFD levels noted in gearbox, possible bearing wear noted in spectral data of drive end bearing of input shaft. There are also some frequencies noted in the intermediate and output shaft that appear to be related to either the gearmesh of the final gearset or possible ball spin defect on one of the bearings of the 2 <sup>nd</sup> gearbox shaft. See attachment for HFD trend.	<b>Medium</b>
-----------------------------	---	---------------

RECOMMENDED ACTION: Schedule drive end bearing of gearbox input shaft for replacement within 45 day time frame. Inspect the 2<sup>nd</sup> shaft bearings (rollers) for wear at time of repair. MDI will advise after next inspection of any further change / improvement.
