**XYZ CORPORATION**

**Balance Report**

Six dryer fans were balanced at the XYZ Corporation M/D/Y. This report contains information related to that balance.

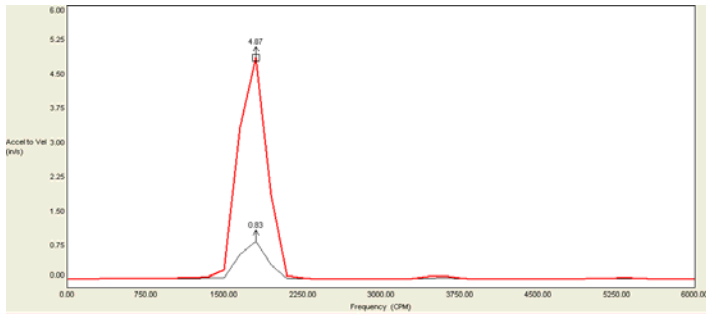
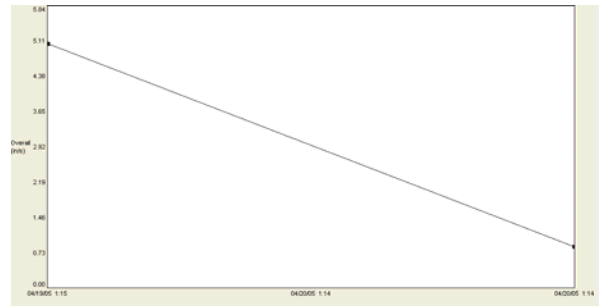
**53-201 Opposite Drive-End Motor Bearing Before and After Balance :**

6. An unusually large amount of balance weight had to be applied to fans 53-201 and 53-204. Fan 53-201 required approximately 16 oz. of weight and fan 53-204 required approximately 22 oz.

7. There was no visible evidence that fans 53-201, 53-202, 53-203 and 53-204 were balanced prior to the arrival of MDI. There were no weights visible on the rotor and there was no evidence of metal removal from the rotor, fan structure or fan seal. MDI is suspects that these fans were not balanced prior to installation.

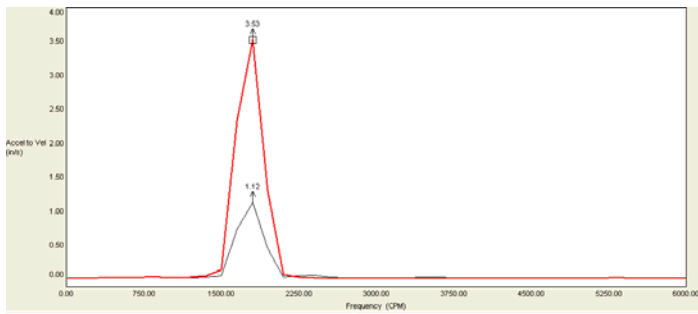
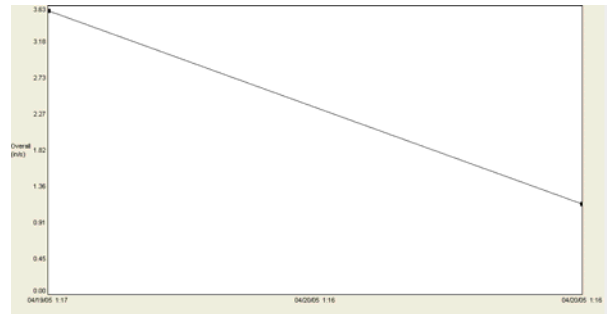
**53-202 Opposite Drive-End Motor Bearing Before and After Balance :**

5. Fans 53-201, 53-202, 53-203 and 53-204 were so significantly out of balance that it was unsafe to operate them at full rpm. These fans were first balanced at half speed, 30 Hz. then trim balanced at 60 Hz.

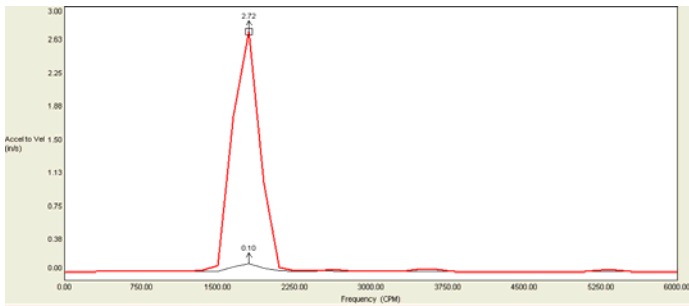
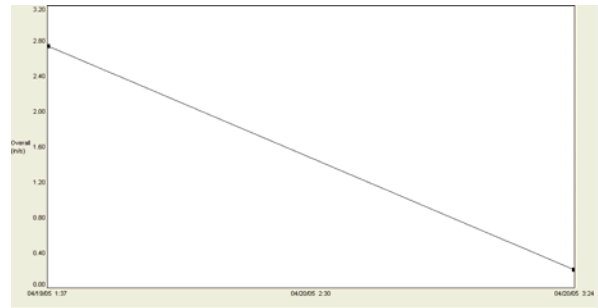
**53-231 Opposite Drive-End Motor Bearing Before and After Balance :**

8. Fans 53-231 and 53-232 have evidence of balance prior to the arrival of MDI. Weights were present on the rotors.
9. Fan 53-231 seems to be somewhat eccentric by perhaps as much as  $\frac{3}{4}$  inches. The fan rotor appears to not be centered rotor to cone.

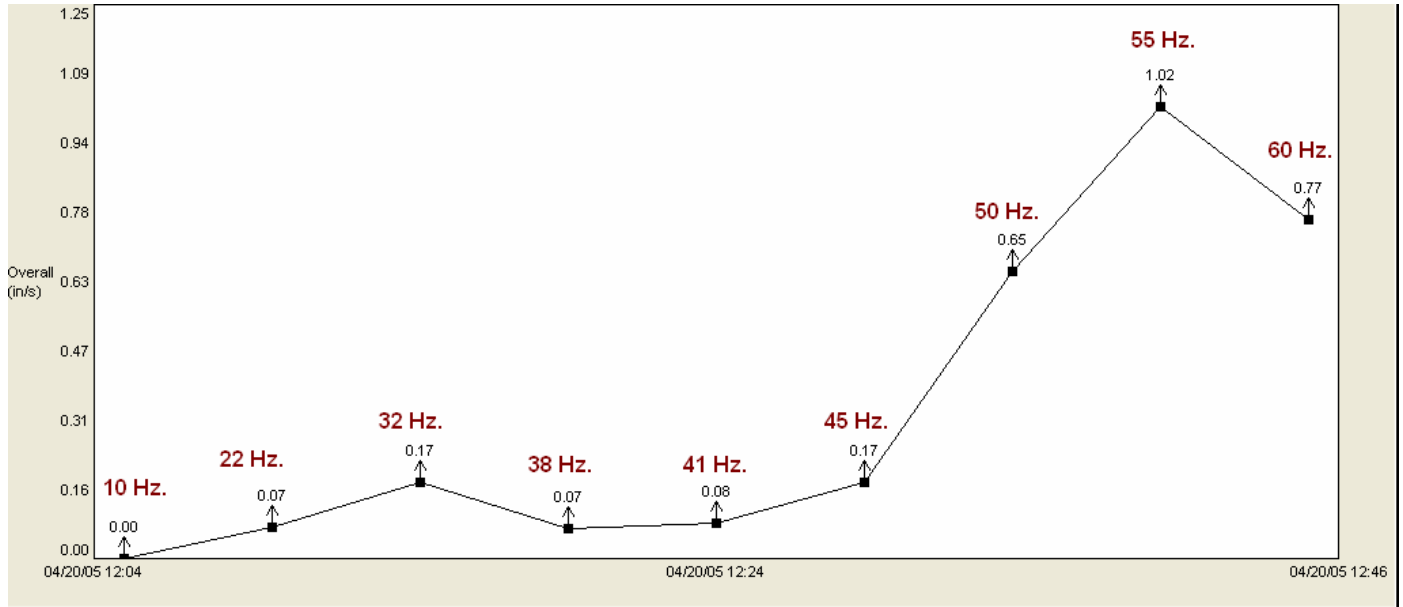
3. All of the fans exhibited characteristics of having either resonance, looseness or structural weakness (or a combination) at approximately 50 Hz. – 55 Hz. This condition is problematic as the fans increase in vibration amplitude disproportionately at this frequency range. For pure unbalance, the amplitude should increase to the square of the speed. As an example, doubling the speed should produce four times the amount of vibration. Two of the fans, 53-201 and 53-202 were chosen for testing at various frequencies (plots attached). These tests show that the amplitudes increases were as much as sixty nine times (see plot for fan 53-202 at 30 Hz. vs. 60 Hz.) when the speed was doubled. This condition makes field balancing of the fans at full speed virtually impossible. It is the opinion of MDI that this condition should be addressed if operation at the 50 Hz. to 60 Hz. range is desired.

**Plot of Variable Frequency Testing on Fan 53-201 Illustrating Increase in Vibration at 50 – 60 Hz.**

1. Consult the fan manufacturer on the subject of a possible resonant frequency range or structural weakness issue at 50 Hz. to 60 Hz. Perhaps they are aware of the condition and can offer some tested solution. Inspect for any loose mounting components.
2. Perform testing on the fans to determine if the condition is resonant or structural weakness (or a combination of both.) Solutions can be considered once the source is properly identified.

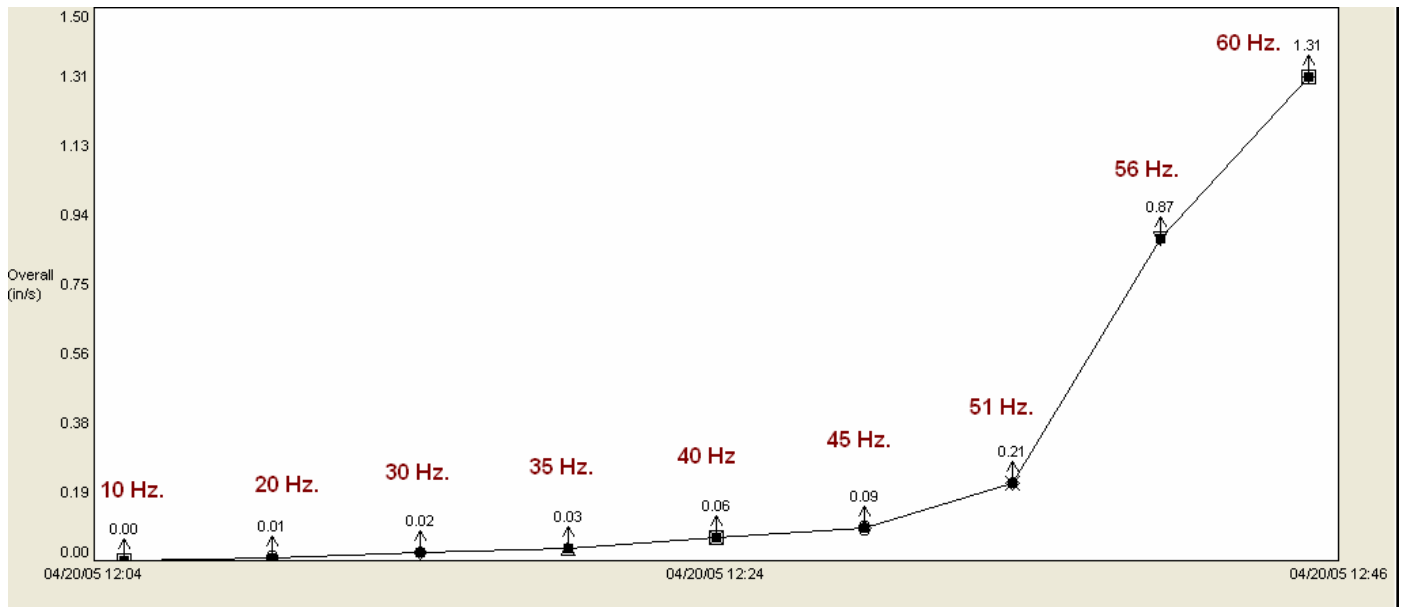
**Plot of Variable Frequency Testing on Fan 53-202 Illustrating Increase in Vibration at 50 – 60 Hz.**
