MACHINERY VIBRATION REPORT

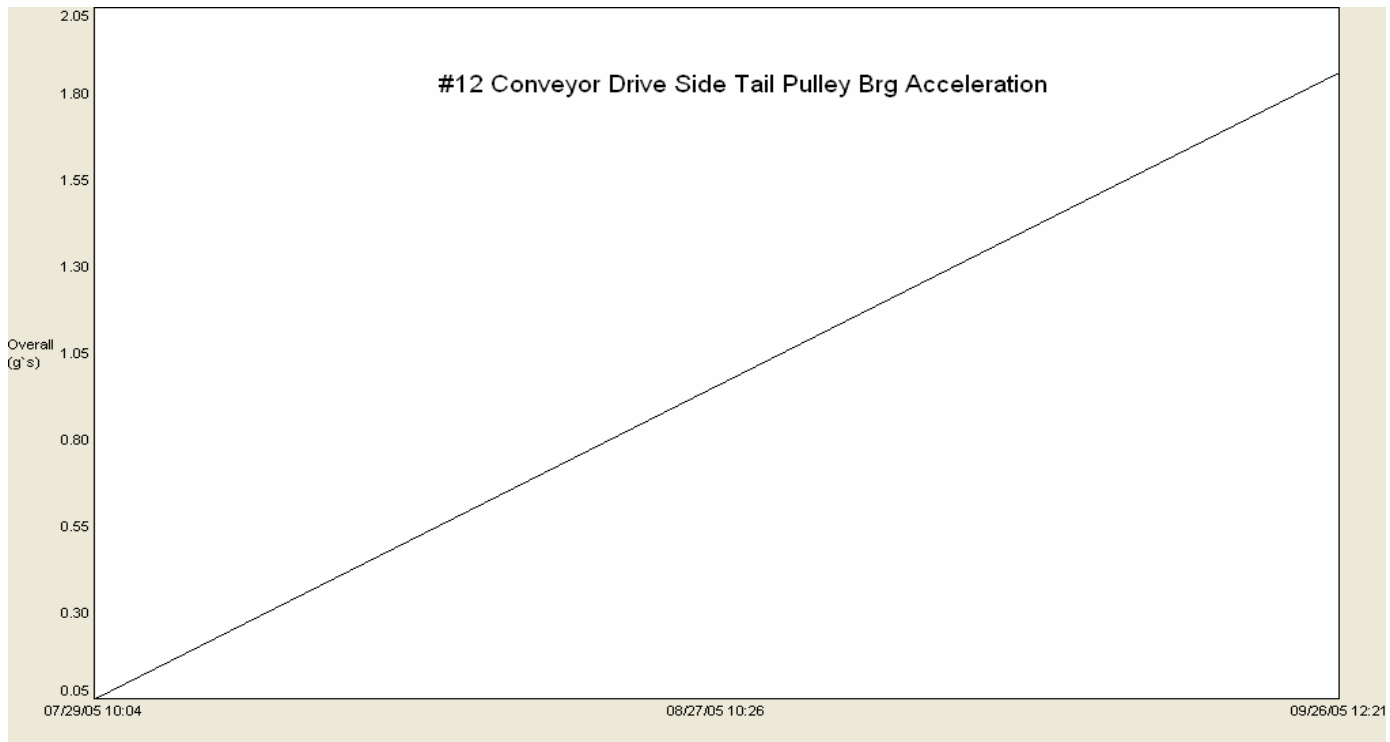
EQUIPMENT NAME	PROBLEM DESCRIPTION	PRIORITY
Conveyor #12	HFD and acceleration levels have trended up sharply on the drive side tail pulley bearing. Potential rub or worn bearing.	Med-High
RECOMMENDED ACTION:	Inspect drive side tail pulley bearing for rubbing or bearing wear. Repair based on inspection results.
