# Leak Report

## *XYZ Corp Recycle Area*

Inspected By: Andy Dortch on 2024-05-17 15:30:28

### **Based on System: XYZ Corp - Air**

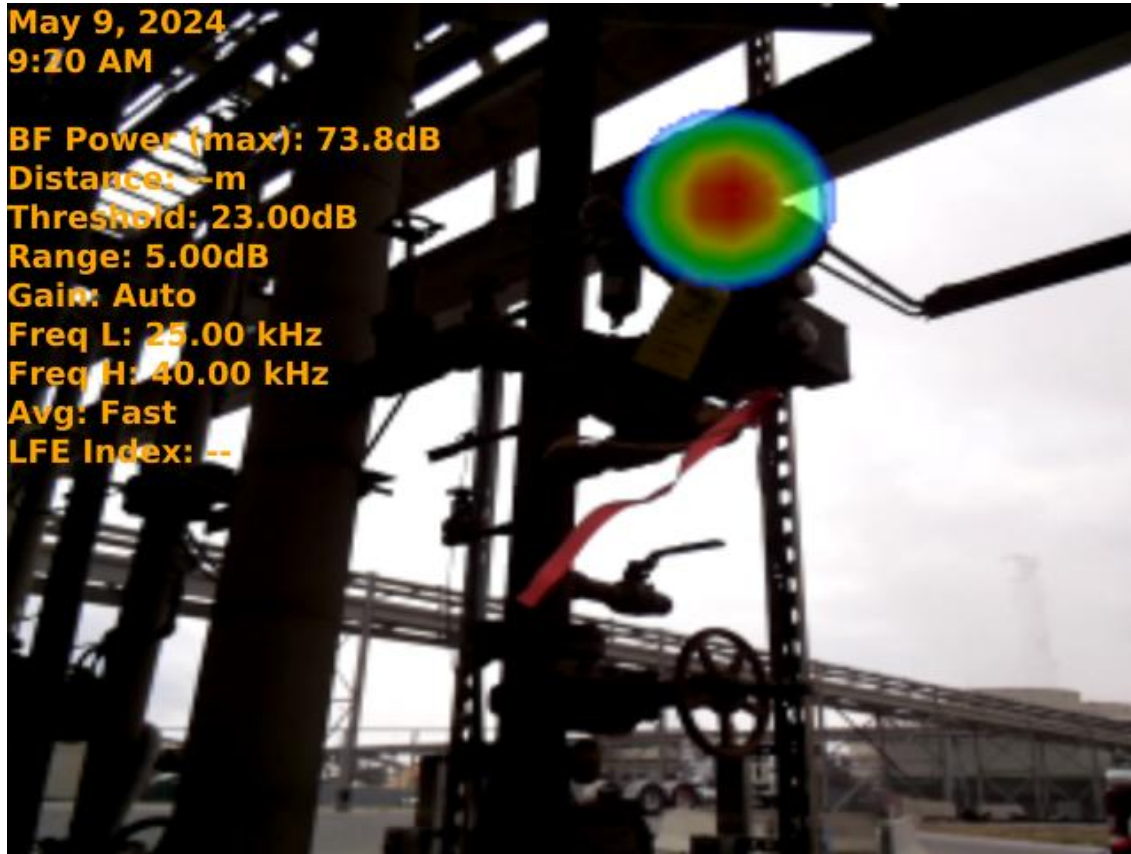
**File: 2024\_May\_9\_09\_20\_28.jpg**

**Status Point 1 - 73.8 dB: NOT REPAIRED**

Estimated Leak Flow Rate for Point 1: 0.51 CFM | 14452.448 CCM | 0.867 CMH

Estimated Annual Loss Impact for Point 1: USD 1960 - USD 2395

#3156 recyc, auto cv above pmp b076, tubing fitting.

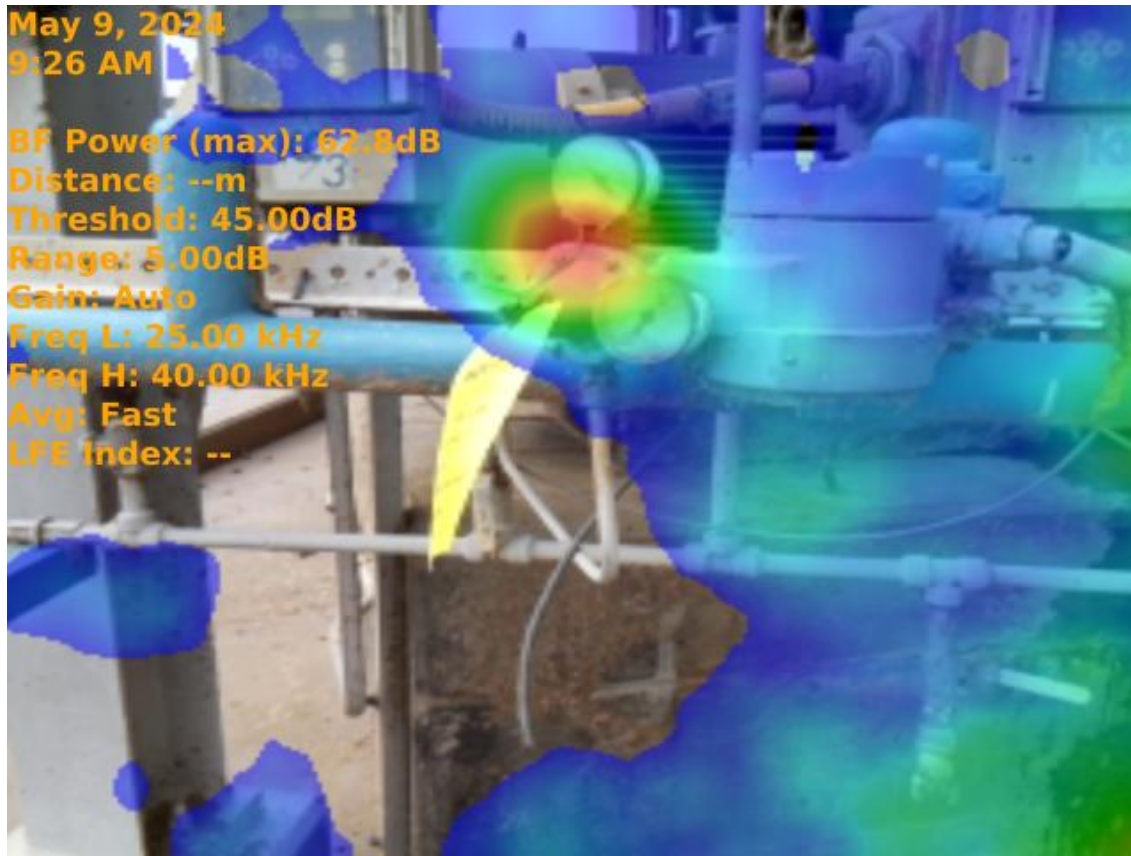
**File: 2024\_May\_9\_09\_26\_18.jpg**

**Status Point 1 - 62.8 dB: NOT REPAIRED**

Estimated Leak Flow Rate for Point 1: 0.193 CFM | 5455.123 CCM | 0.327 CMH

Estimated Annual Loss Impact for Point 1: USD 740 - USD 904

#3157 recyc, i/p reg at pmp 5058, leaks by.

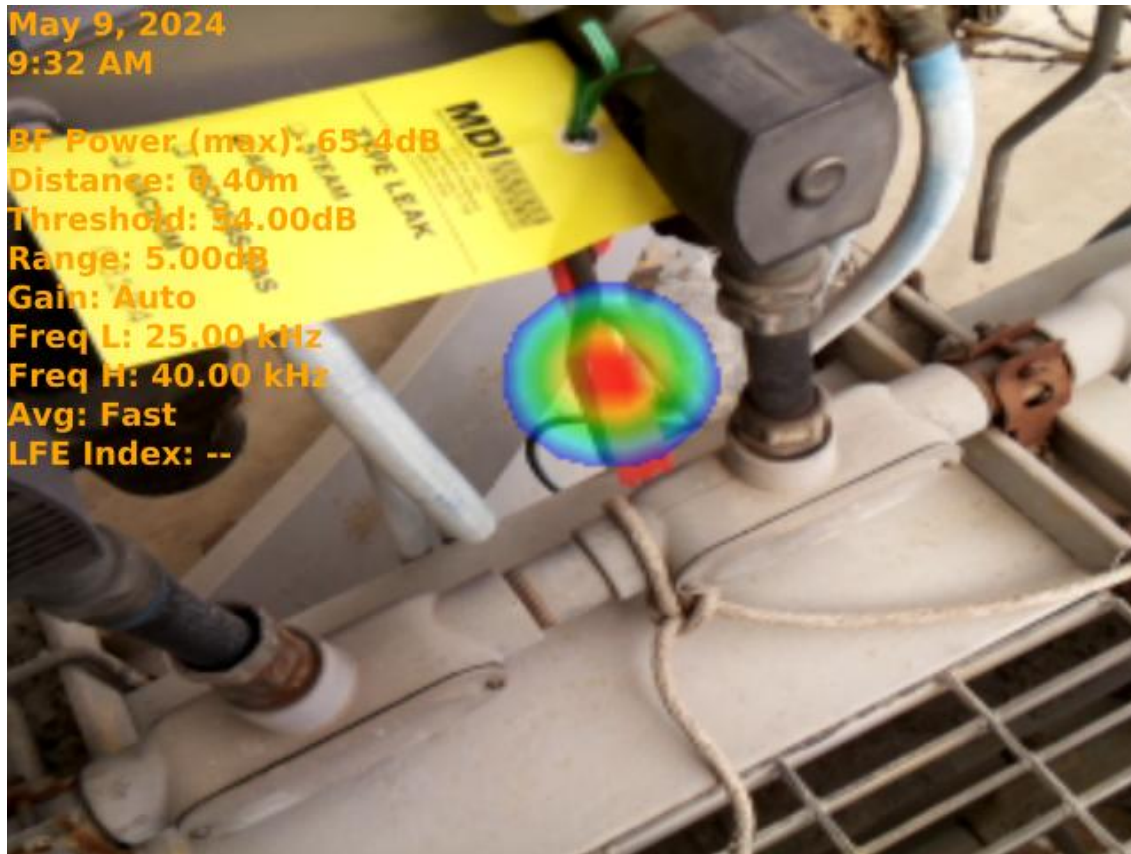
### File: 2024\_May\_9\_09\_32\_21.jpg

#### Status Point 1 - 65.4 dB: NOT REPAIRED

Estimated Leak Flow Rate for Point 1: 0.03 CFM | 857.082 CCM | 0.051 CMH  
Estimated Annual Loss Impact for Point 1: USD 117 - USD 143

#3184 recyc, valve mezz at hd chest #8, sol valve r24-232 dumping air.

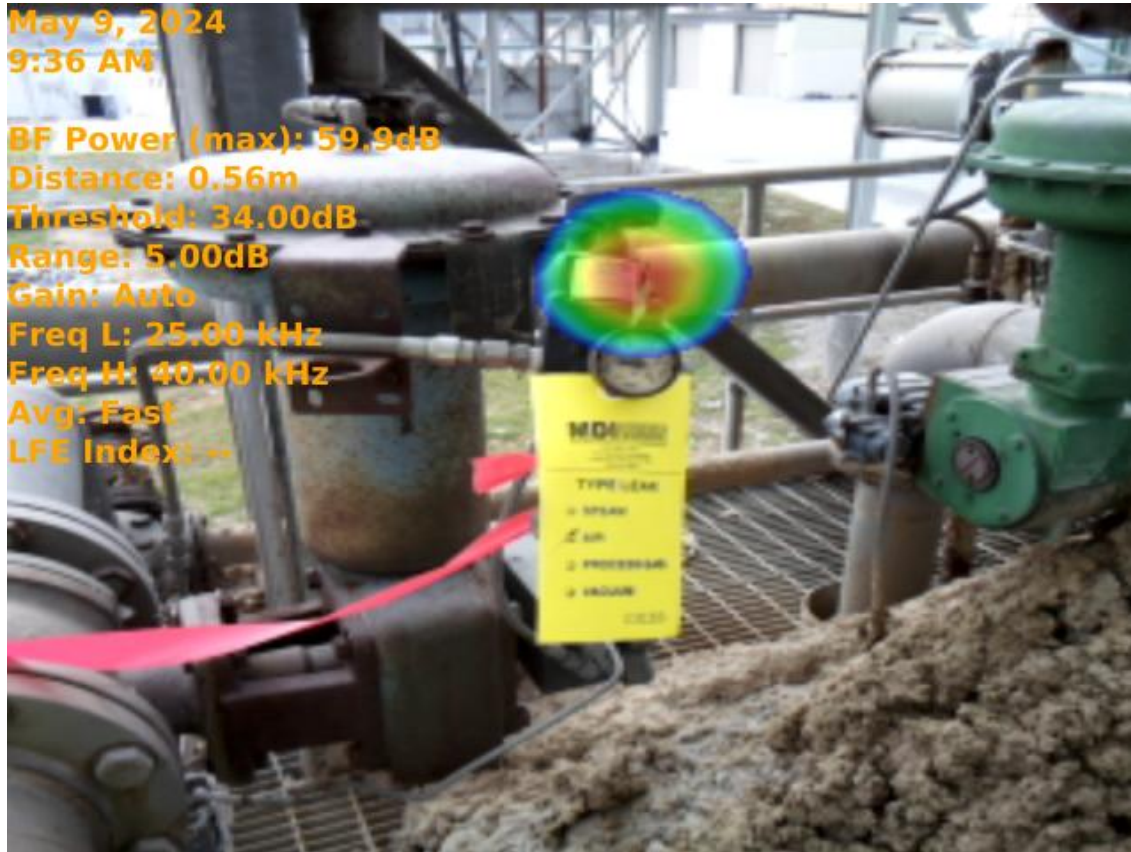
**File: 2024\_May\_9\_09\_36\_44.jpg**

**Status Point 1 - 59.9 dB: NOT REPAIRED**

Estimated Leak Flow Rate for Point 1: 0.027 CFM | 768.747 CCM | 0.046 CMH  
Estimated Annual Loss Impact for Point 1: USD 105 - USD 128

#3158 recyc, valve mezz at hd chest #8, auto cv reg gauge.

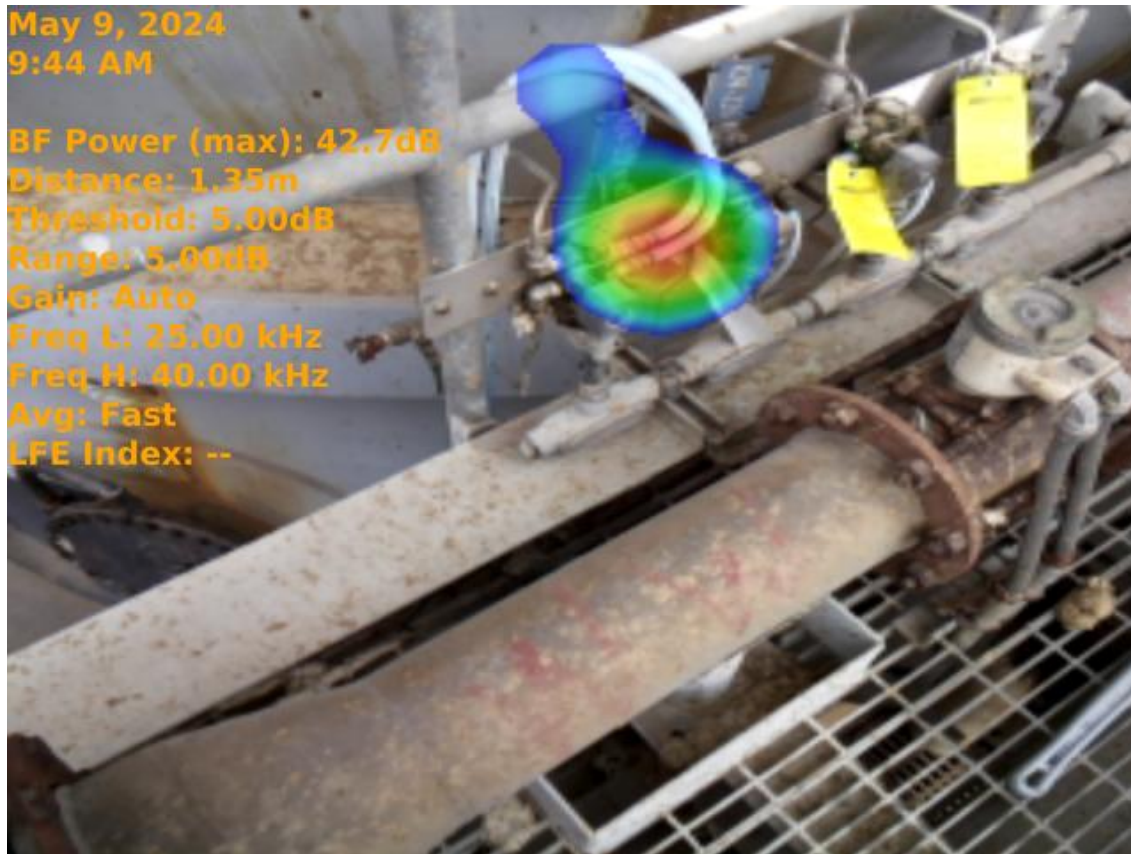
**File: 2024\_May\_9\_09\_44\_03.jpg**

**Status Point 1 - 42.7 dB: NOT REPAIRED**

Estimated Leak Flow Rate for Point 1: 0.014 CFM | 409.605 CCM | 0.025 CMH  
Estimated Annual Loss Impact for Point 1: USD 56 - USD 68

#3183 recyc, valve mezz at hd chest #8, r24-227 sol dumping.

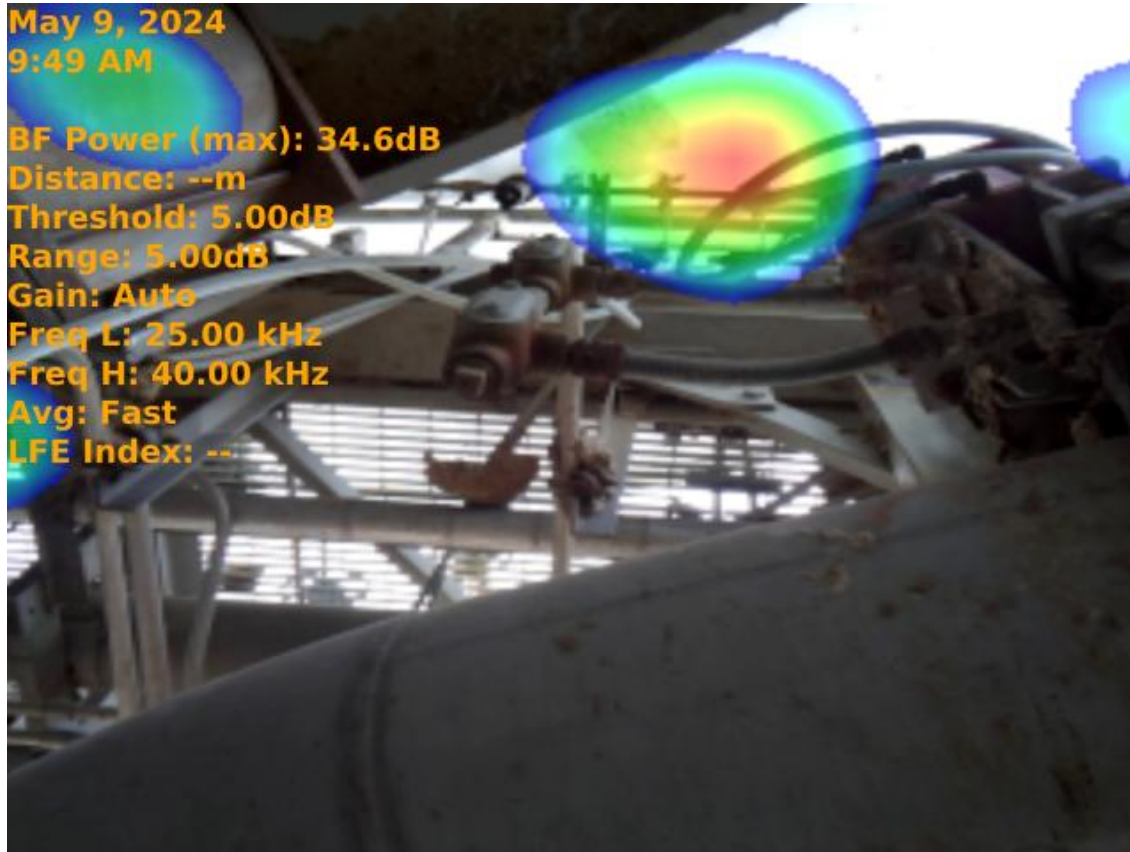
**File: 2024\_May\_9\_09\_49\_31.jpg**

**Status Point 1 - 34.3 dB: NOT REPAIRED**

Estimated Leak Flow Rate for Point 1: 0.015 CFM | 420.494 CCM | 0.025 CMH

Estimated Annual Loss Impact for Point 1: USD 58 - USD 70

#2116 &amp; 2117 recyc, valve mezz at hd chest #8, sol valves next to r27-227 leaking.

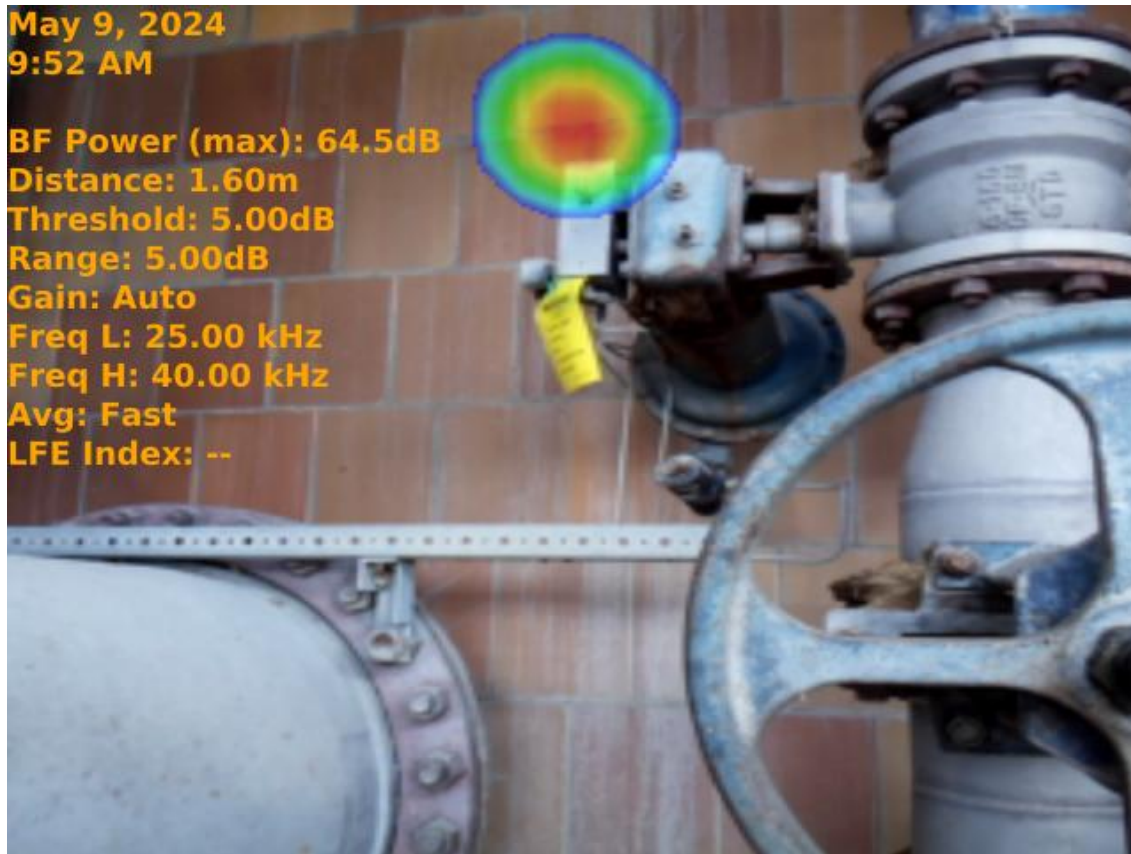
**File: 2024\_May\_9\_09\_52\_43.jpg**

**Status Point 1 - 64.5 dB: NOT REPAIRED**

Estimated Leak Flow Rate for Point 1: 0.119 CFM | 3358.257 CCM | 0.201 CMH  
Estimated Annual Loss Impact for Point 1: USD 456 - USD 557

#3159 recyc, #1 cleaners feed chst, auto cv controller gauge.

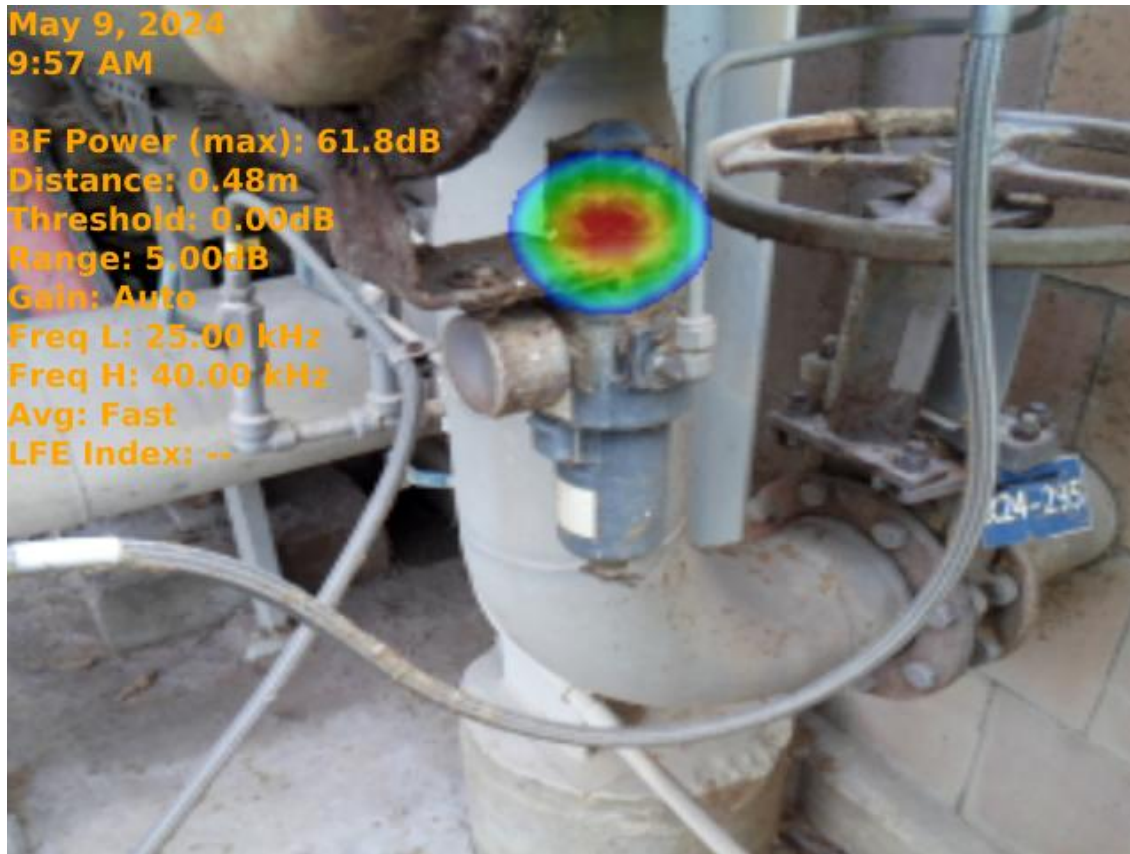
**File: 2024\_May\_9\_09\_57\_17.jpg**

**Status Point 1 - 61.8 dB: NOT REPAIRED**

Estimated Leak Flow Rate for Point 1: 0.027 CFM | 770.555 CCM | 0.046 CMH  
Estimated Annual Loss Impact for Point 1: USD 105 - USD 128

#3162 recyc, left of cleaners feed chst agit b032, auto cv reg body leaks.

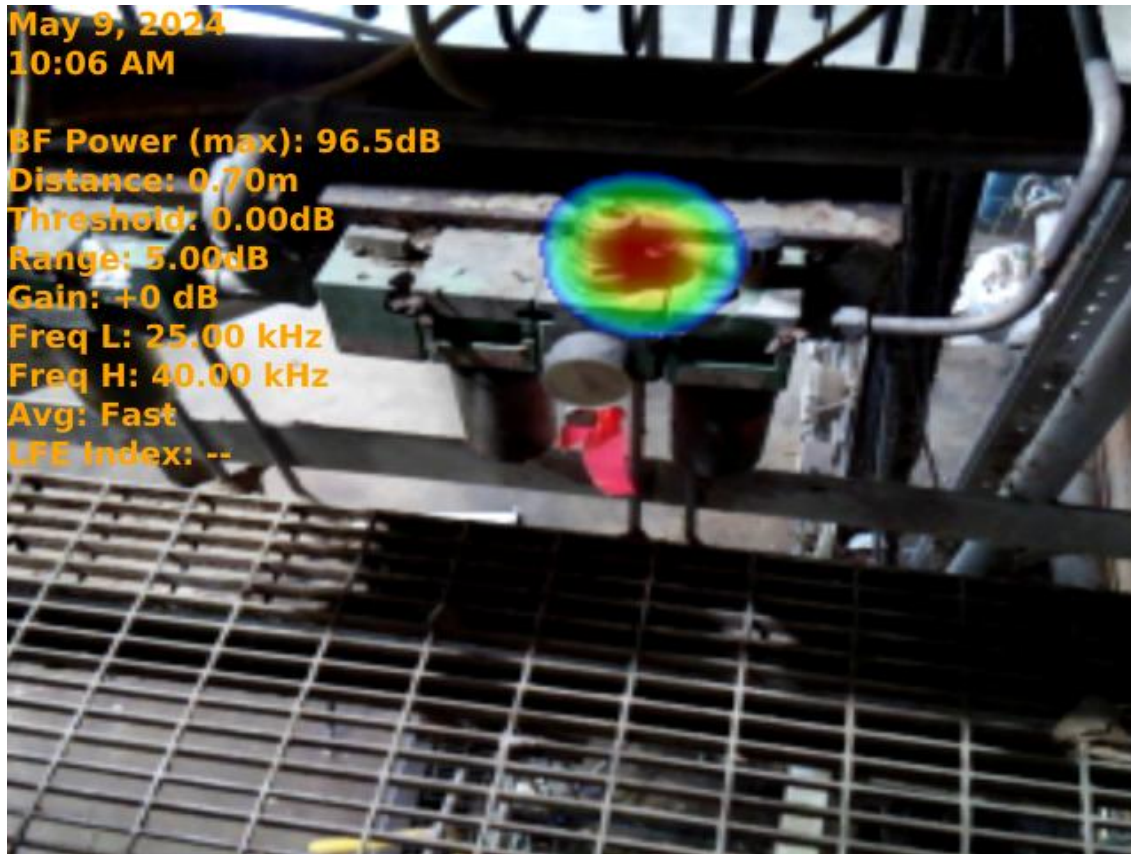
**File: 2024\_May\_9\_10\_06\_09.jpg**

**Status Point 1 - 96.5 dB: NOT REPAIRED**

Estimated Leak Flow Rate for Point 1: 0.293 CFM | 8286.986 CCM | 0.497 CMH  
Estimated Annual Loss Impact for Point 1: USD 1124 - USD 1374

#3163 recyc, sand separator, pneu enclosure, reg body.

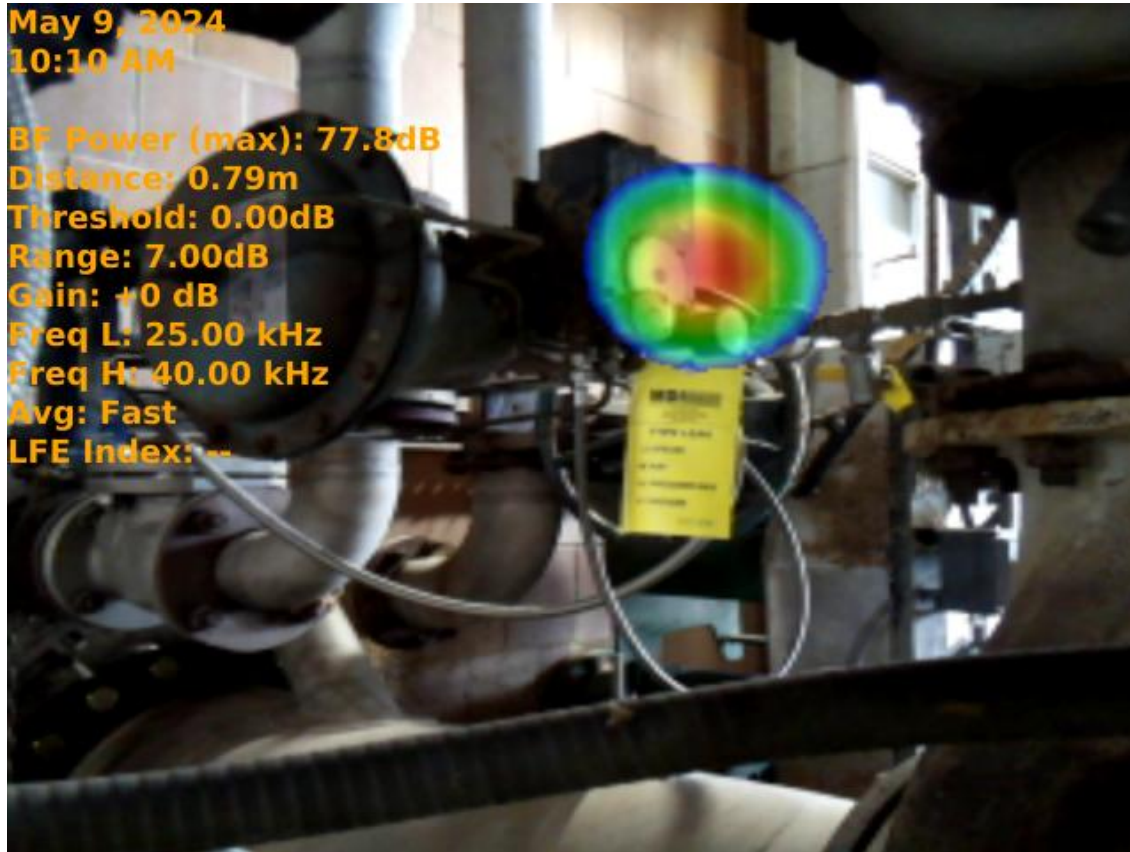
**File: 2024\_May\_9\_10\_10\_48.jpg**

**Status Point 1 - 77.8 dB: NOT REPAIRED**

Estimated Leak Flow Rate for Point 1: 0.174 CFM | 4918.589 CCM | 0.295 CMH  
Estimated Annual Loss Impact for Point 1: USD 667 - USD 815

#3164 recyc, course screen fd pmp b013, auto cv gauge

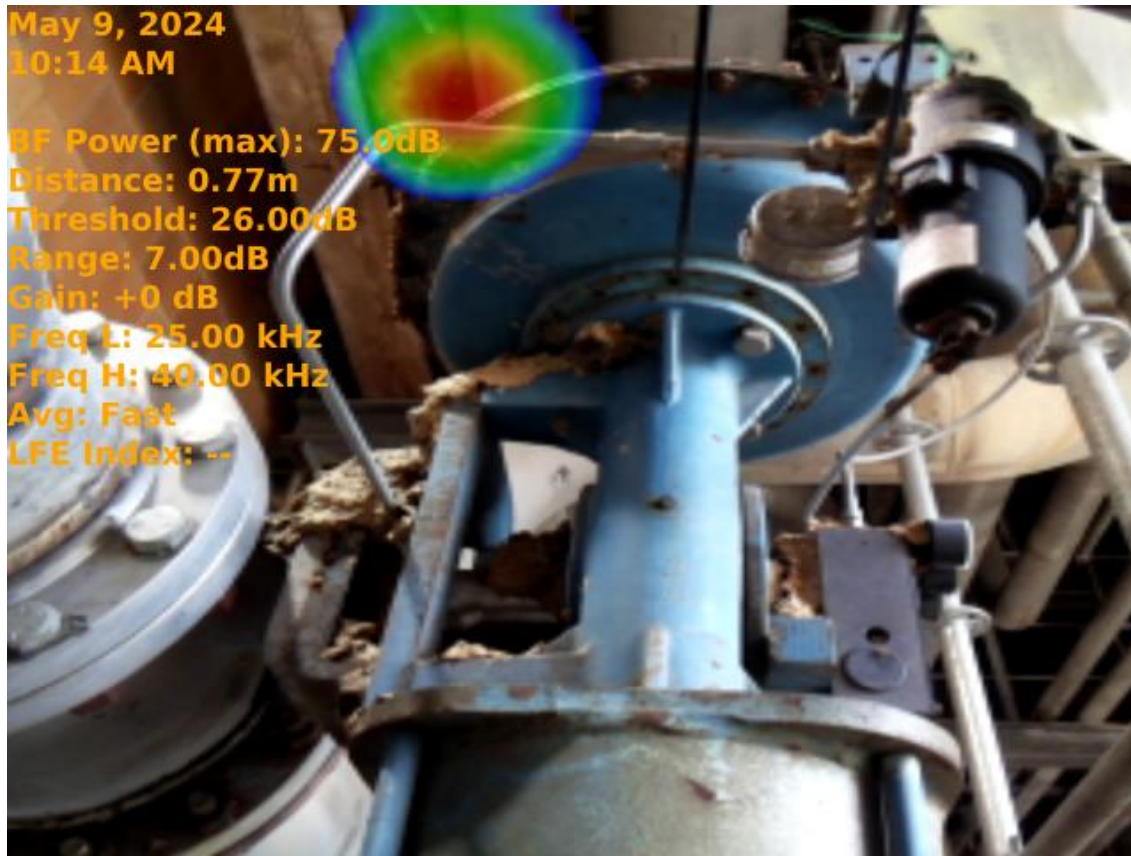
**File: 2024\_May\_9\_10\_14\_33.jpg**

**Status Point 1 - 75 dB: NOT REPAIRED**

Estimated Leak Flow Rate for Point 1: 0.135 CFM | 3826.212 CCM | 0.23 CMH  
Estimated Annual Loss Impact for Point 1: USD 519 - USD 634

#3161 recyc, fine scrn feed chst, auto cv actuator diaphragm leaks.

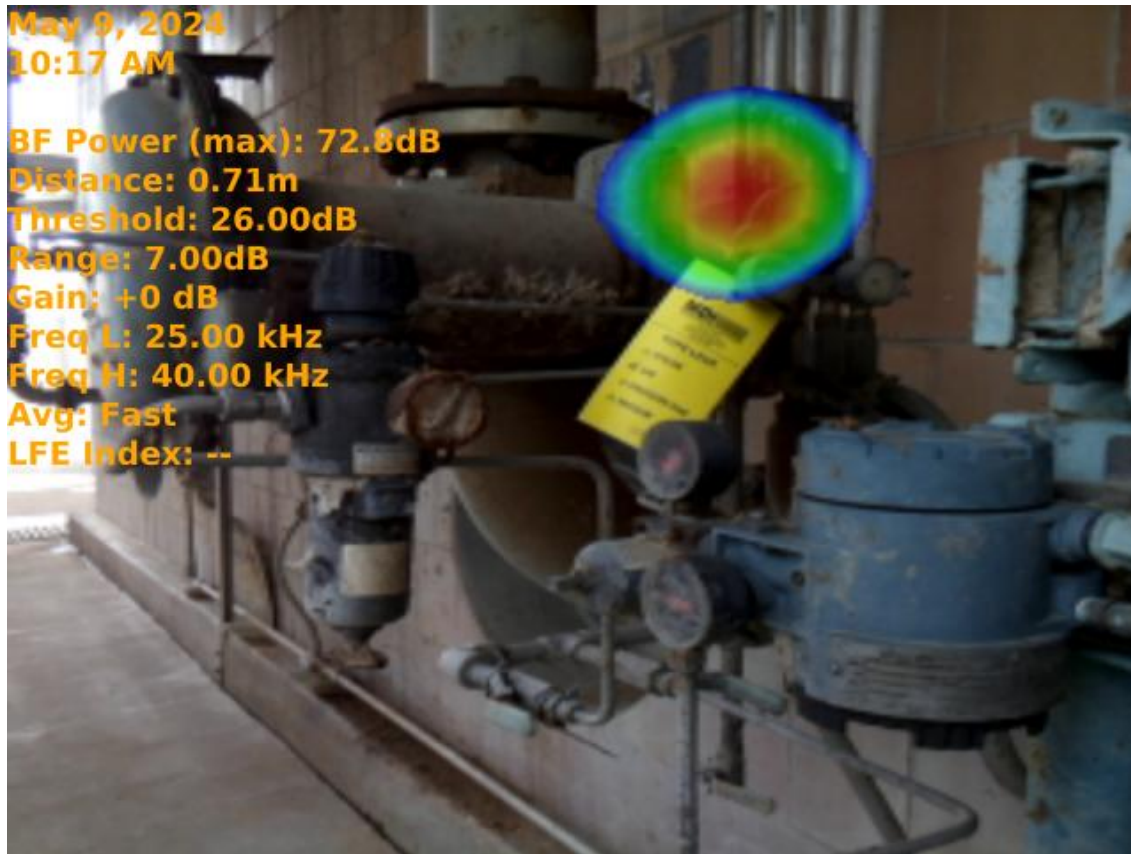
**File: 2024\_May\_9\_10\_17\_48.jpg**

**Status Point 1 - 72.8 dB: NOT REPAIRED**

Estimated Leak Flow Rate for Point 1: 0.103 CFM | 2927.814 CCM | 0.176 CMH  
Estimated Annual Loss Impact for Point 1: USD 397 - USD 486

#3165 recyc, sec fine screen feed chst, auto cv posit gauge leaks.

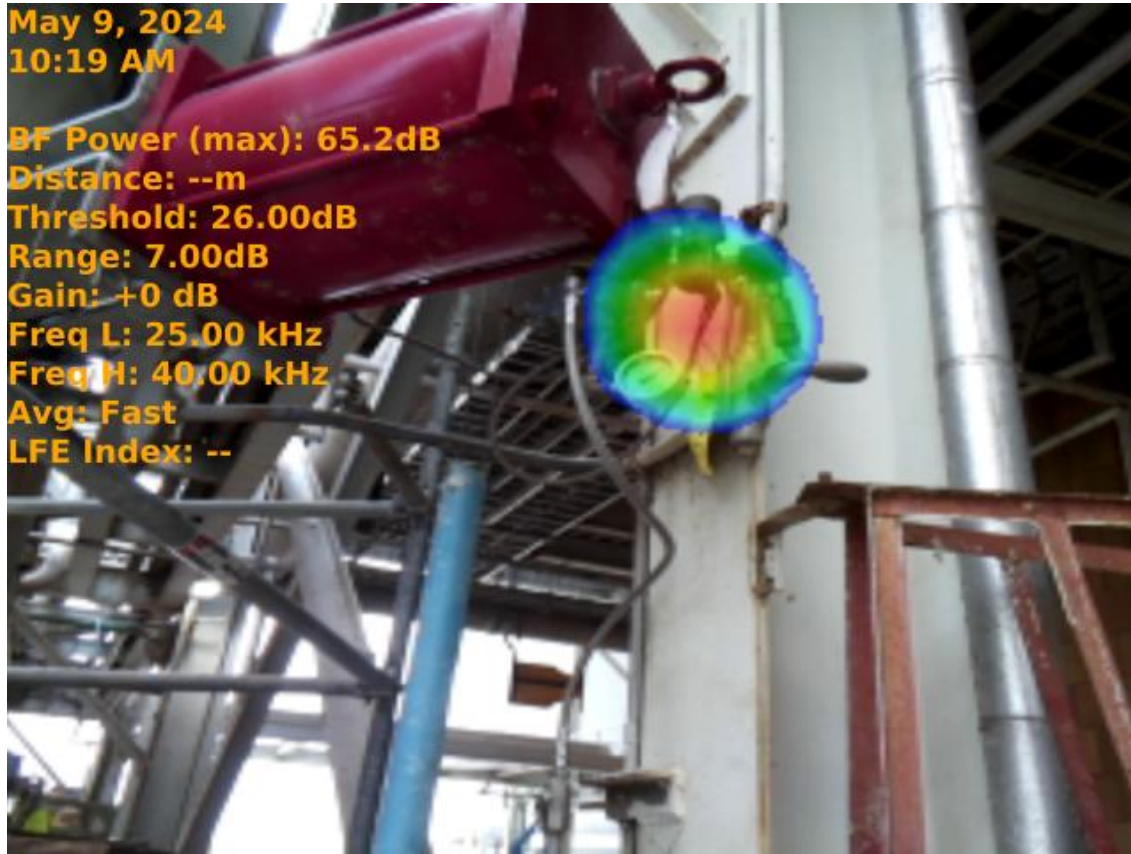
**File: 2024\_May\_9\_10\_19\_55.jpg**

**Status Point 1 - 65.2 dB: NOT REPAIRED**

Estimated Leak Flow Rate for Point 1: 0.239 CFM | 6754.439 CCM | 0.405 CMH

Estimated Annual Loss Impact for Point 1: USD 916 - USD 1120

#3160 recyc, thickner feed chst, sol valve dumping.

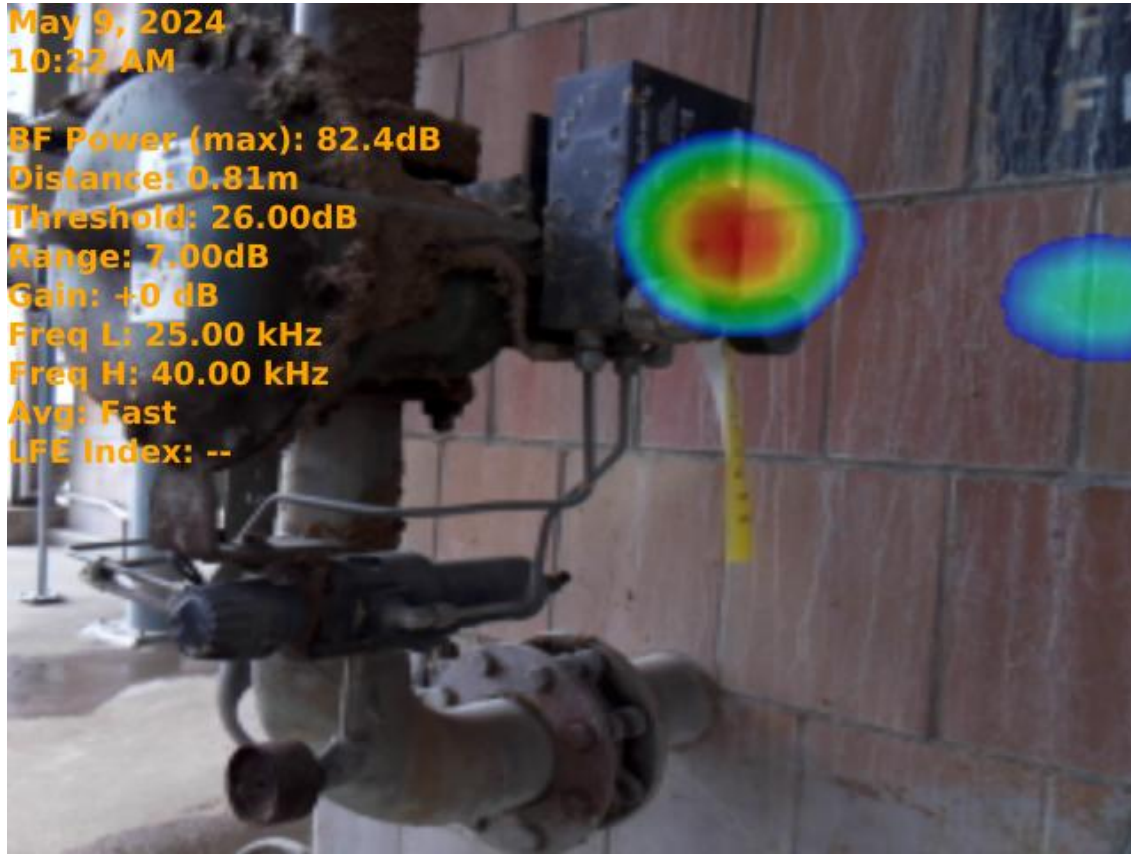
**File: 2024\_May\_9\_10\_22\_55.jpg**

**Status Point 1 - 82.4 dB: NOT REPAIRED**

Estimated Leak Flow Rate for Point 1: 0.253 CFM | 7156.897 CCM | 0.429 CMH  
Estimated Annual Loss Impact for Point 1: USD 971 - USD 1186

#3167 recyc, fine scrn feed chst, auto cv positioner gauge.

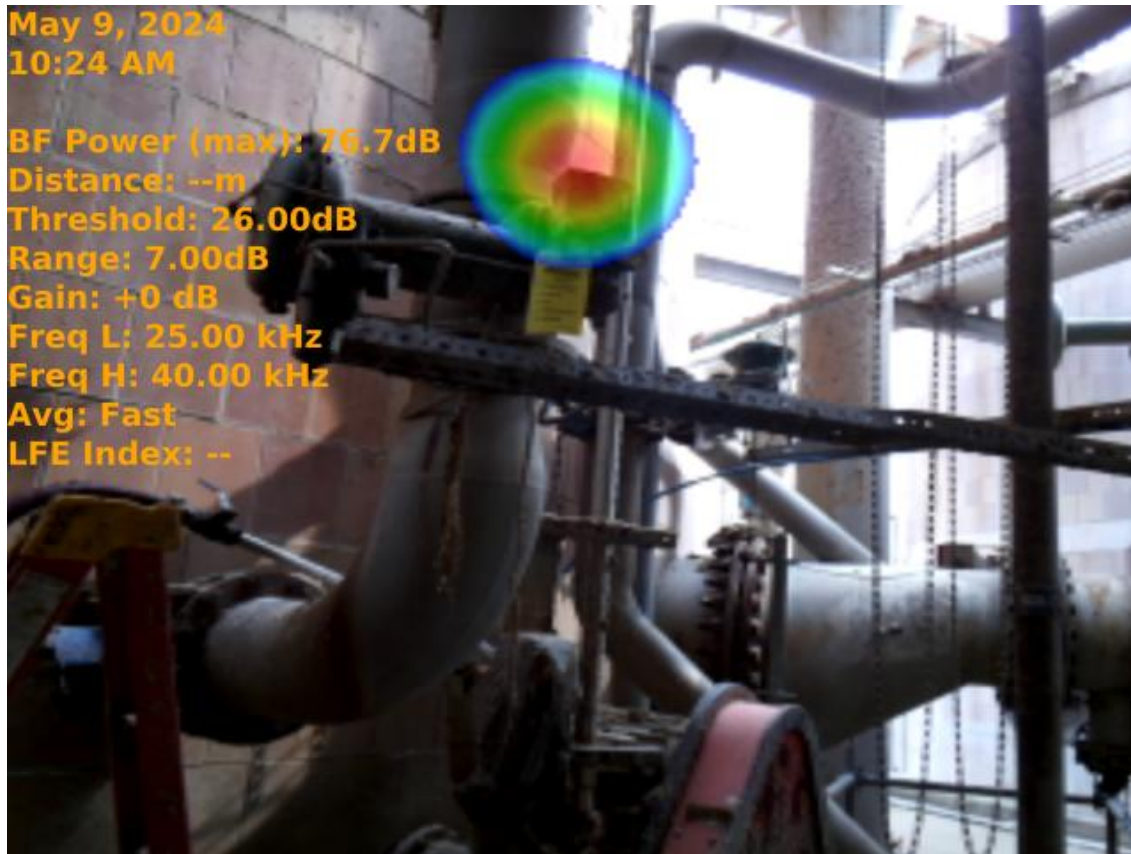
**File: 2024\_May\_9\_10\_24\_41.jpg**

**Status Point 1 - 76.7 dB: NOT REPAIRED**

Estimated Leak Flow Rate for Point 1: 0.658 CFM | 18630.62 CCM | 1.118 CMH

Estimated Annual Loss Impact for Point 1: USD 2526 - USD 3088

#3166 recyc, thickner feed chst, auto cv positioner gauge.

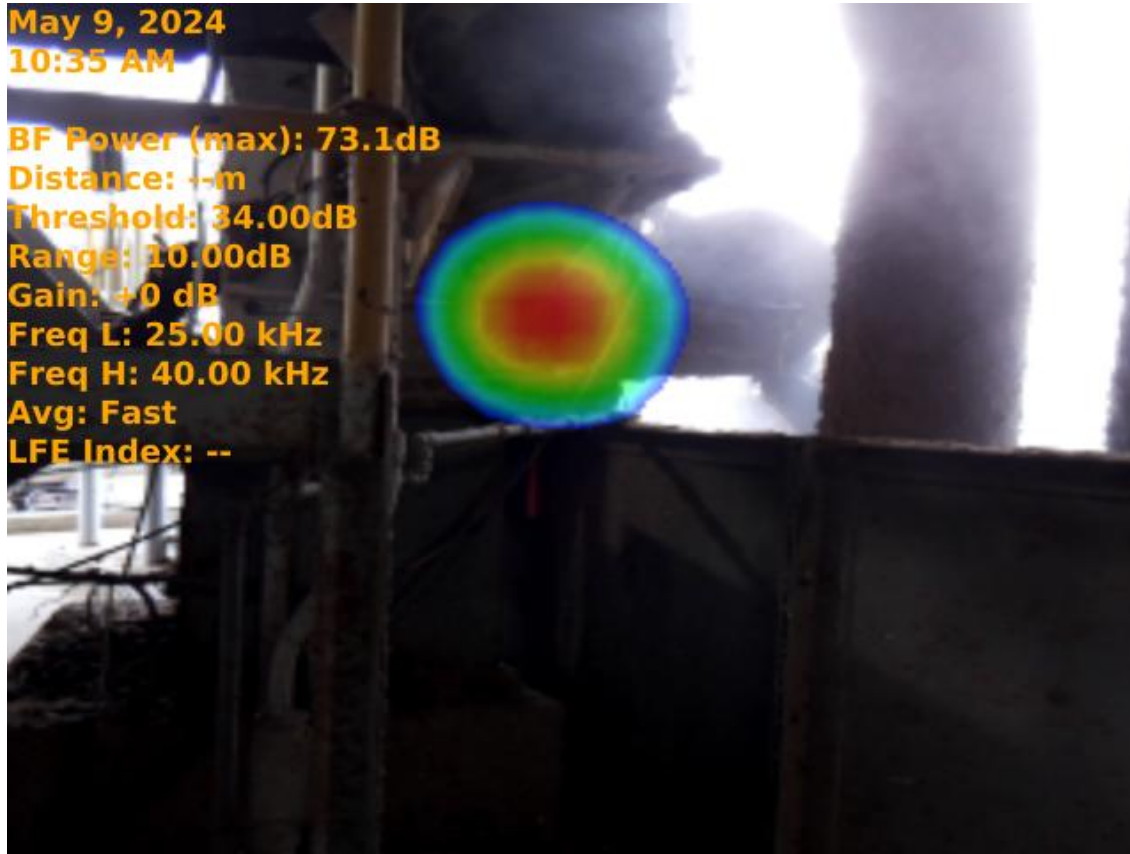
**File: 2024\_May\_9\_10\_35\_39.jpg**

**Status Point 1 - 73.1 dB: NOT REPAIRED**

Estimated Leak Flow Rate for Point 1: 0.48 CFM | 13589.915 CCM | 0.815 CMH

Estimated Annual Loss Impact for Point 1: USD 1843 - USD 2252

#2615 recyc, 2nd floor, under plpr ragger gbx, air hose.

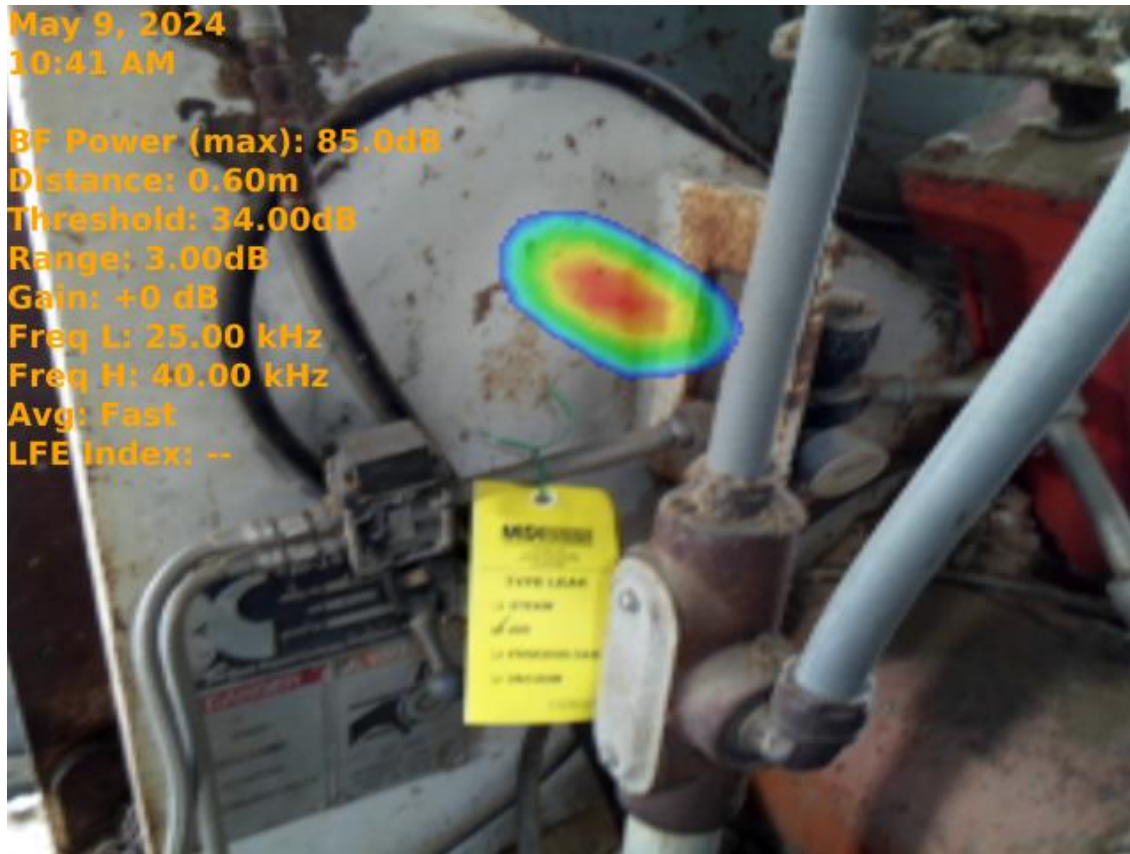
**File: 2024\_May\_9\_10\_41\_50.jpg**

**Status Point 1 - 85 dB: NOT REPAIRED**

Estimated Leak Flow Rate for Point 1: 0.202 CFM | 5733.306 CCM | 0.344 CMH  
Estimated Annual Loss Impact for Point 1: USD 778 - USD 950

#2614 recyc, 2nd floor, beside ragger drive, pipe threads and coupling.

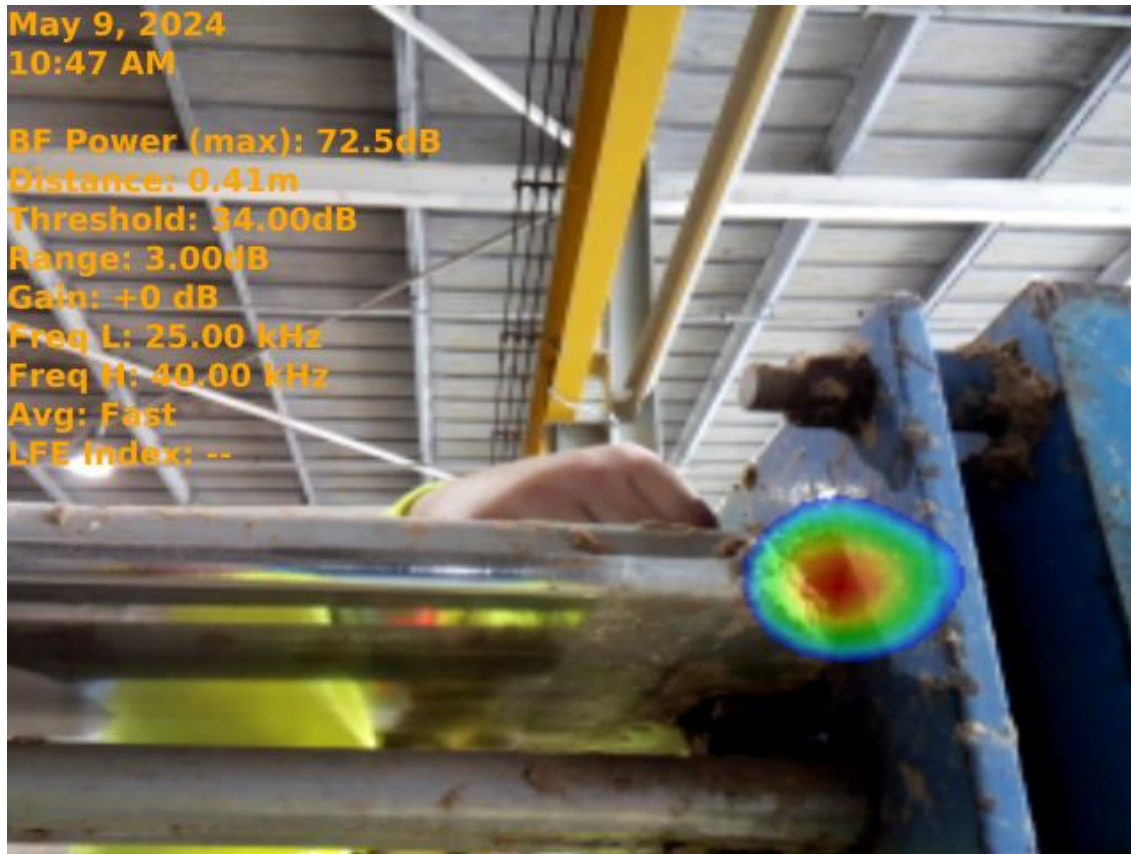
**File: 2024\_May\_9\_10\_47\_25.jpg**

**Status Point 1 - 72.5 dB: NOT REPAIRED**

Estimated Leak Flow Rate for Point 1: 0.054 CFM | 1542.078 CCM | 0.093 CMH  
Estimated Annual Loss Impact for Point 1: USD 210 - USD 256

#3168 recyc, 2nd floor, #1 primary fine screen, gate valve cyl seal.

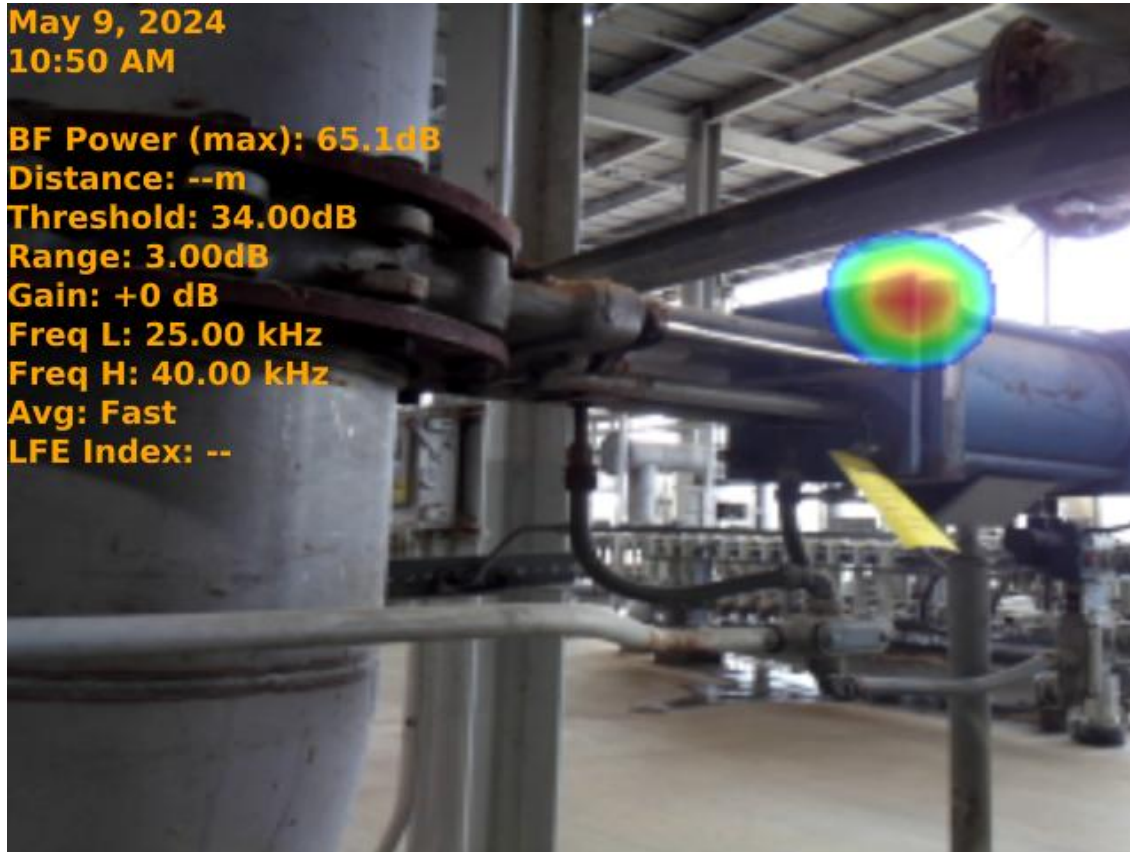
**File: 2024\_May\_9\_10\_50\_53.jpg**

**Status Point 1 - 65 dB: NOT REPAIRED**

Estimated Leak Flow Rate for Point 1: 0.234 CFM | 6635.366 CCM | 0.398 CMH

Estimated Annual Loss Impact for Point 1: USD 900 - USD 1100

#3169 recyc, 2nd floor, #2 primary fine scrn, gate valve cyl seal.

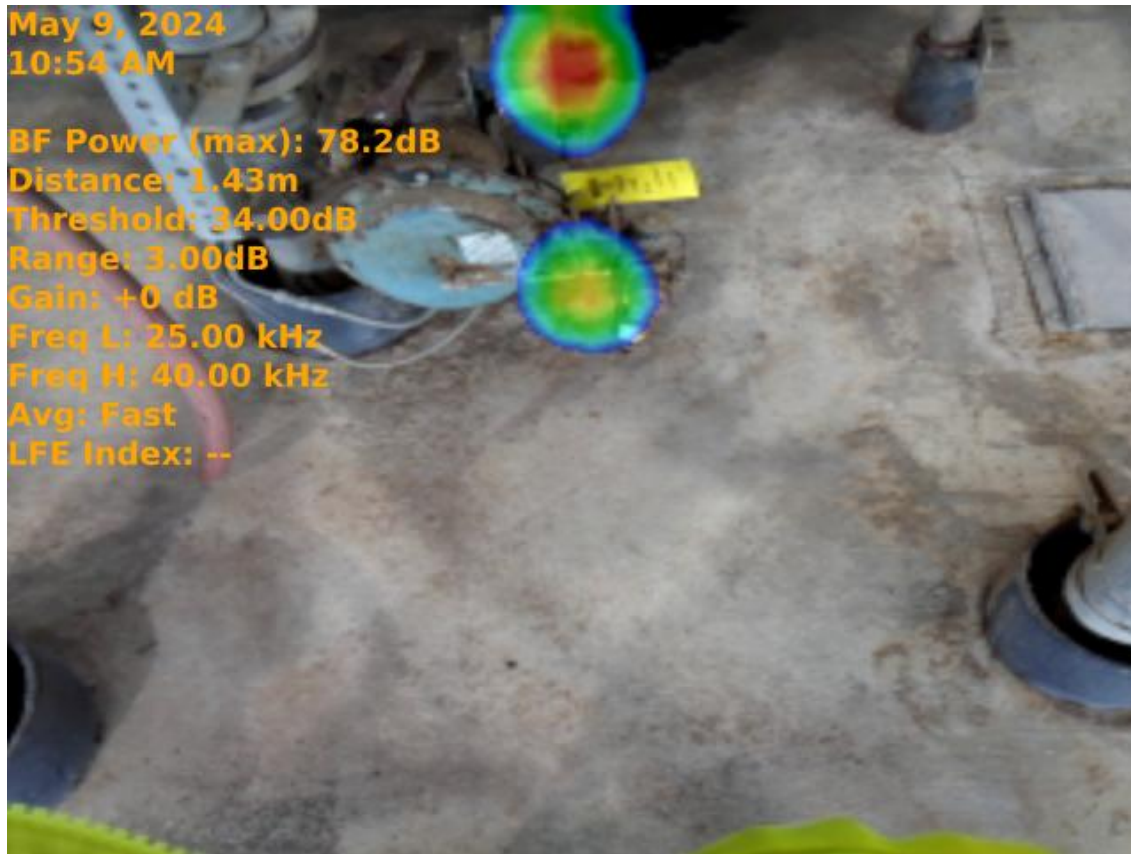
**File: 2024\_May\_9\_10\_54\_02.jpg**

**Status Point 1 - 78.2 dB: NOT REPAIRED**

Estimated Leak Flow Rate for Point 1: 0.344 CFM | 9753.564 CCM | 0.585 CMH  
Estimated Annual Loss Impact for Point 1: USD 1323 - USD 1617

#3170 recyc, 2nd floor tert fine scrn, bottom of valve controller.
