# SAMPLE REPORT

## MACHINERY VIBRATION REPORT

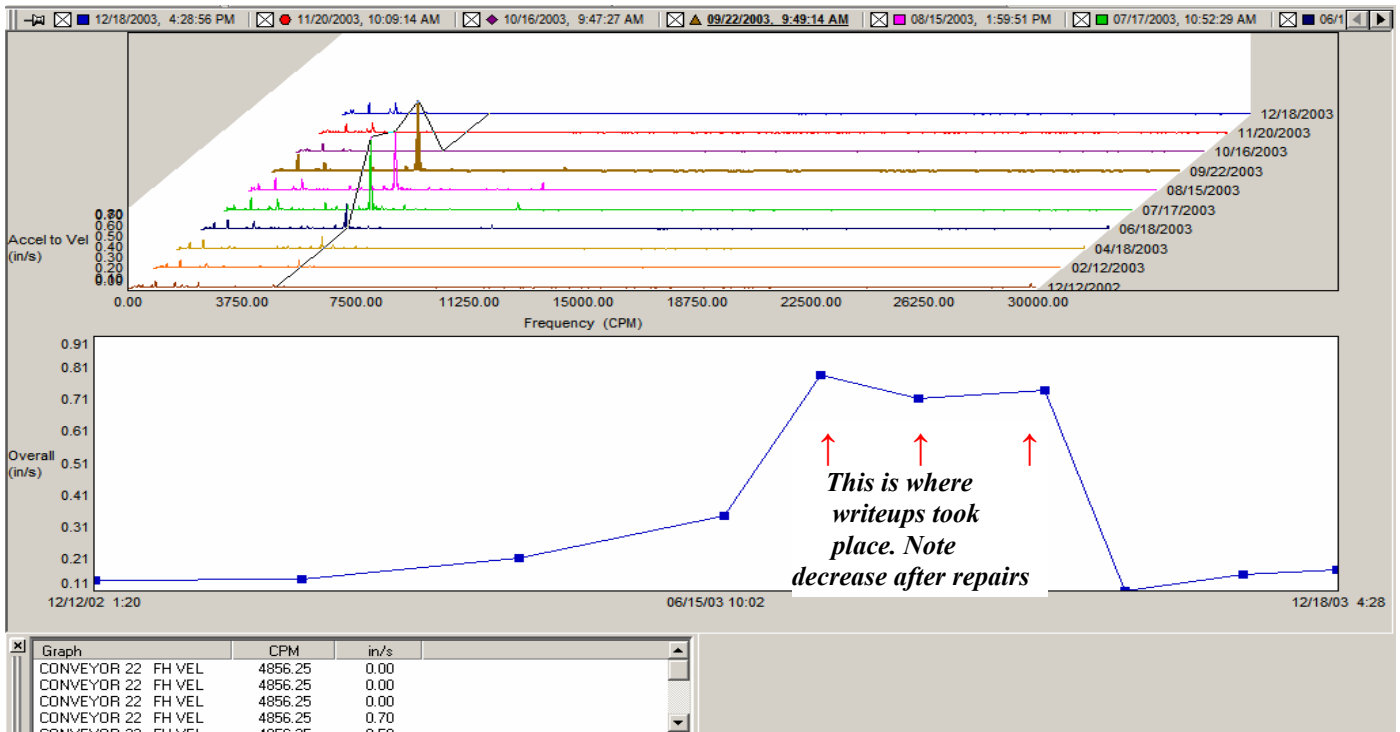
<b>Conveyor 22 (10000122)</b>	HFD levels continue to trend upward at output of gearbox, vibration at suspected gearmeshing frequency of the output gearset continues to increase. Suspect extensive wear in output gearset. See attachment for waterfall spectral plot. <b>No current oil sample noted online.</b>	<b>High</b>
-----------------------------------	--	-------------

<i>Problem Found / Action Taken</i>	Broken tooth / wear on pinion of output gearset.
-------------------------------------	--

RECOMMENDED ACTION: Replace / recondition gearbox promptly.
