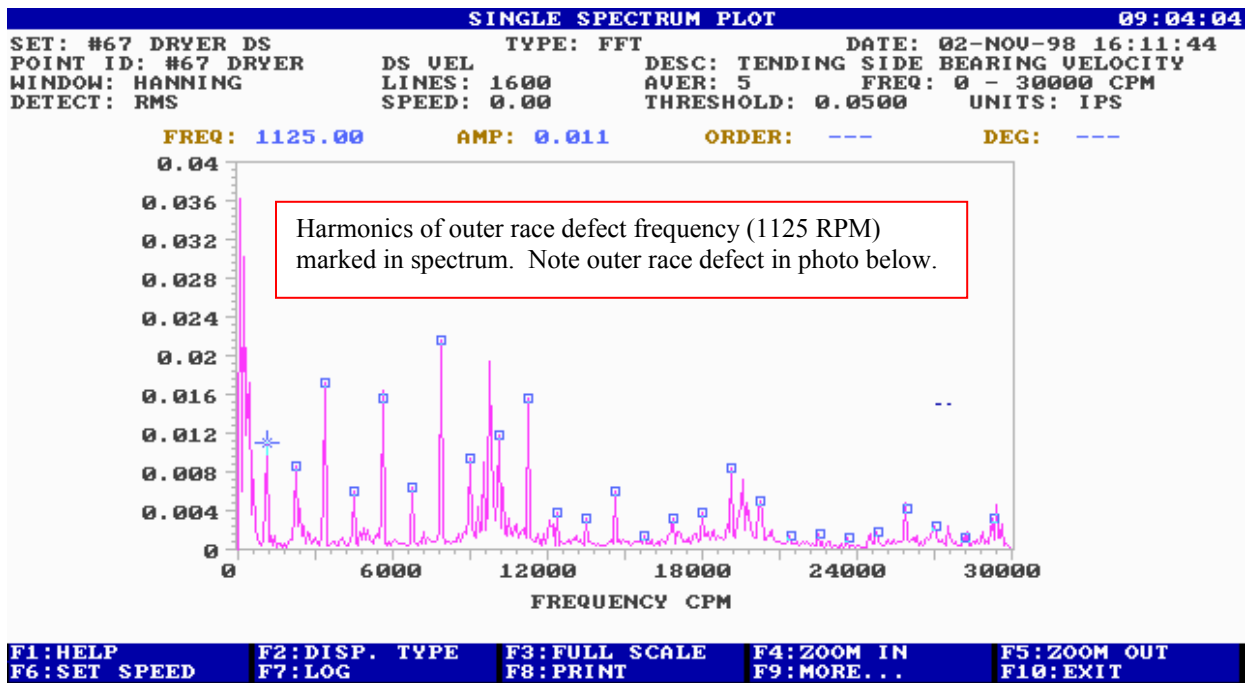
The spectrum above shows harmonics of this bearing's outer race defect frequency at 1125 RPM. These frequencies were produced by a defect 8 inches long and 1 1/2 inches wide.

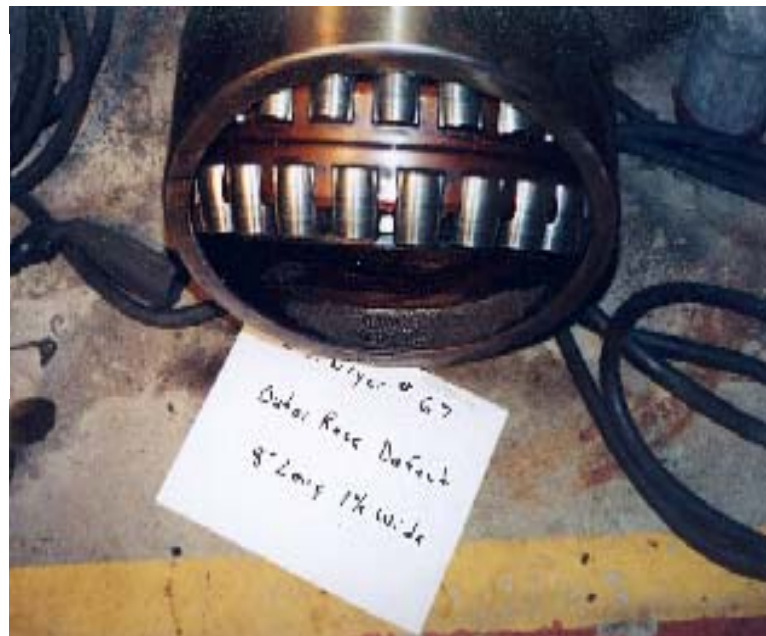
The defects can be seen in this photo at the bottom of the outer race.
