XYZ Corporation
Anywhere, USA

Inspection Date
M/D/Y

MACHINERY VIBRATION REPORT

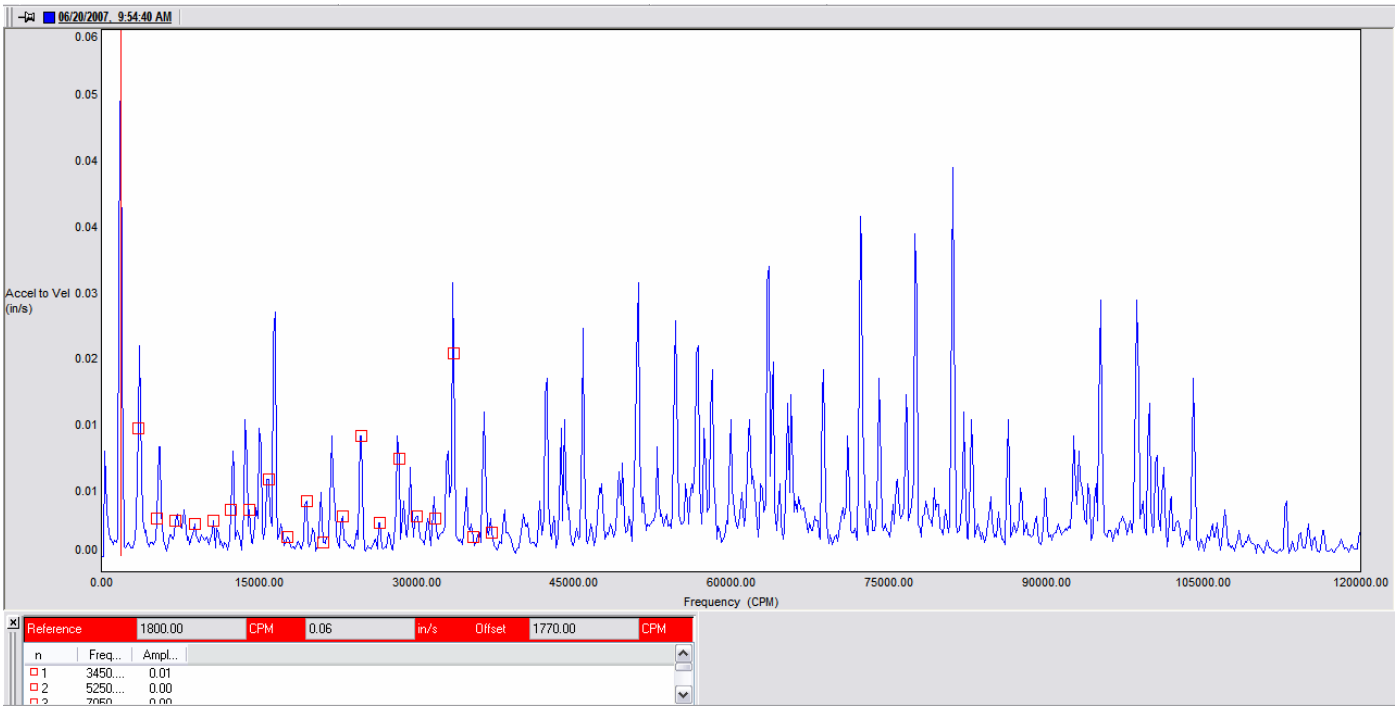
EQUIPMENT NAME	PROBLEM DESCRIPTION	PRIORITY
CHP-1	HFD levels are excessive in pump; spectral data reveals significant looseness / wear.	**Med-High**
RECOMMENDED ACTION:	Ensure pump bearings are properly lubricated. Pump should be replaced / reconditioned within 30 day time frame.	
Action Taken; Problem Found
